## DEPARTMENT OF TRANSPORTATION

SUBJECT: UDOT Project Number S-R199 (381)  
SR-177; SR-193 to 1800 N. (PIN 20927)  
*Environmental Impact Statement Re-evaluation 15*

Traffic Noise Study

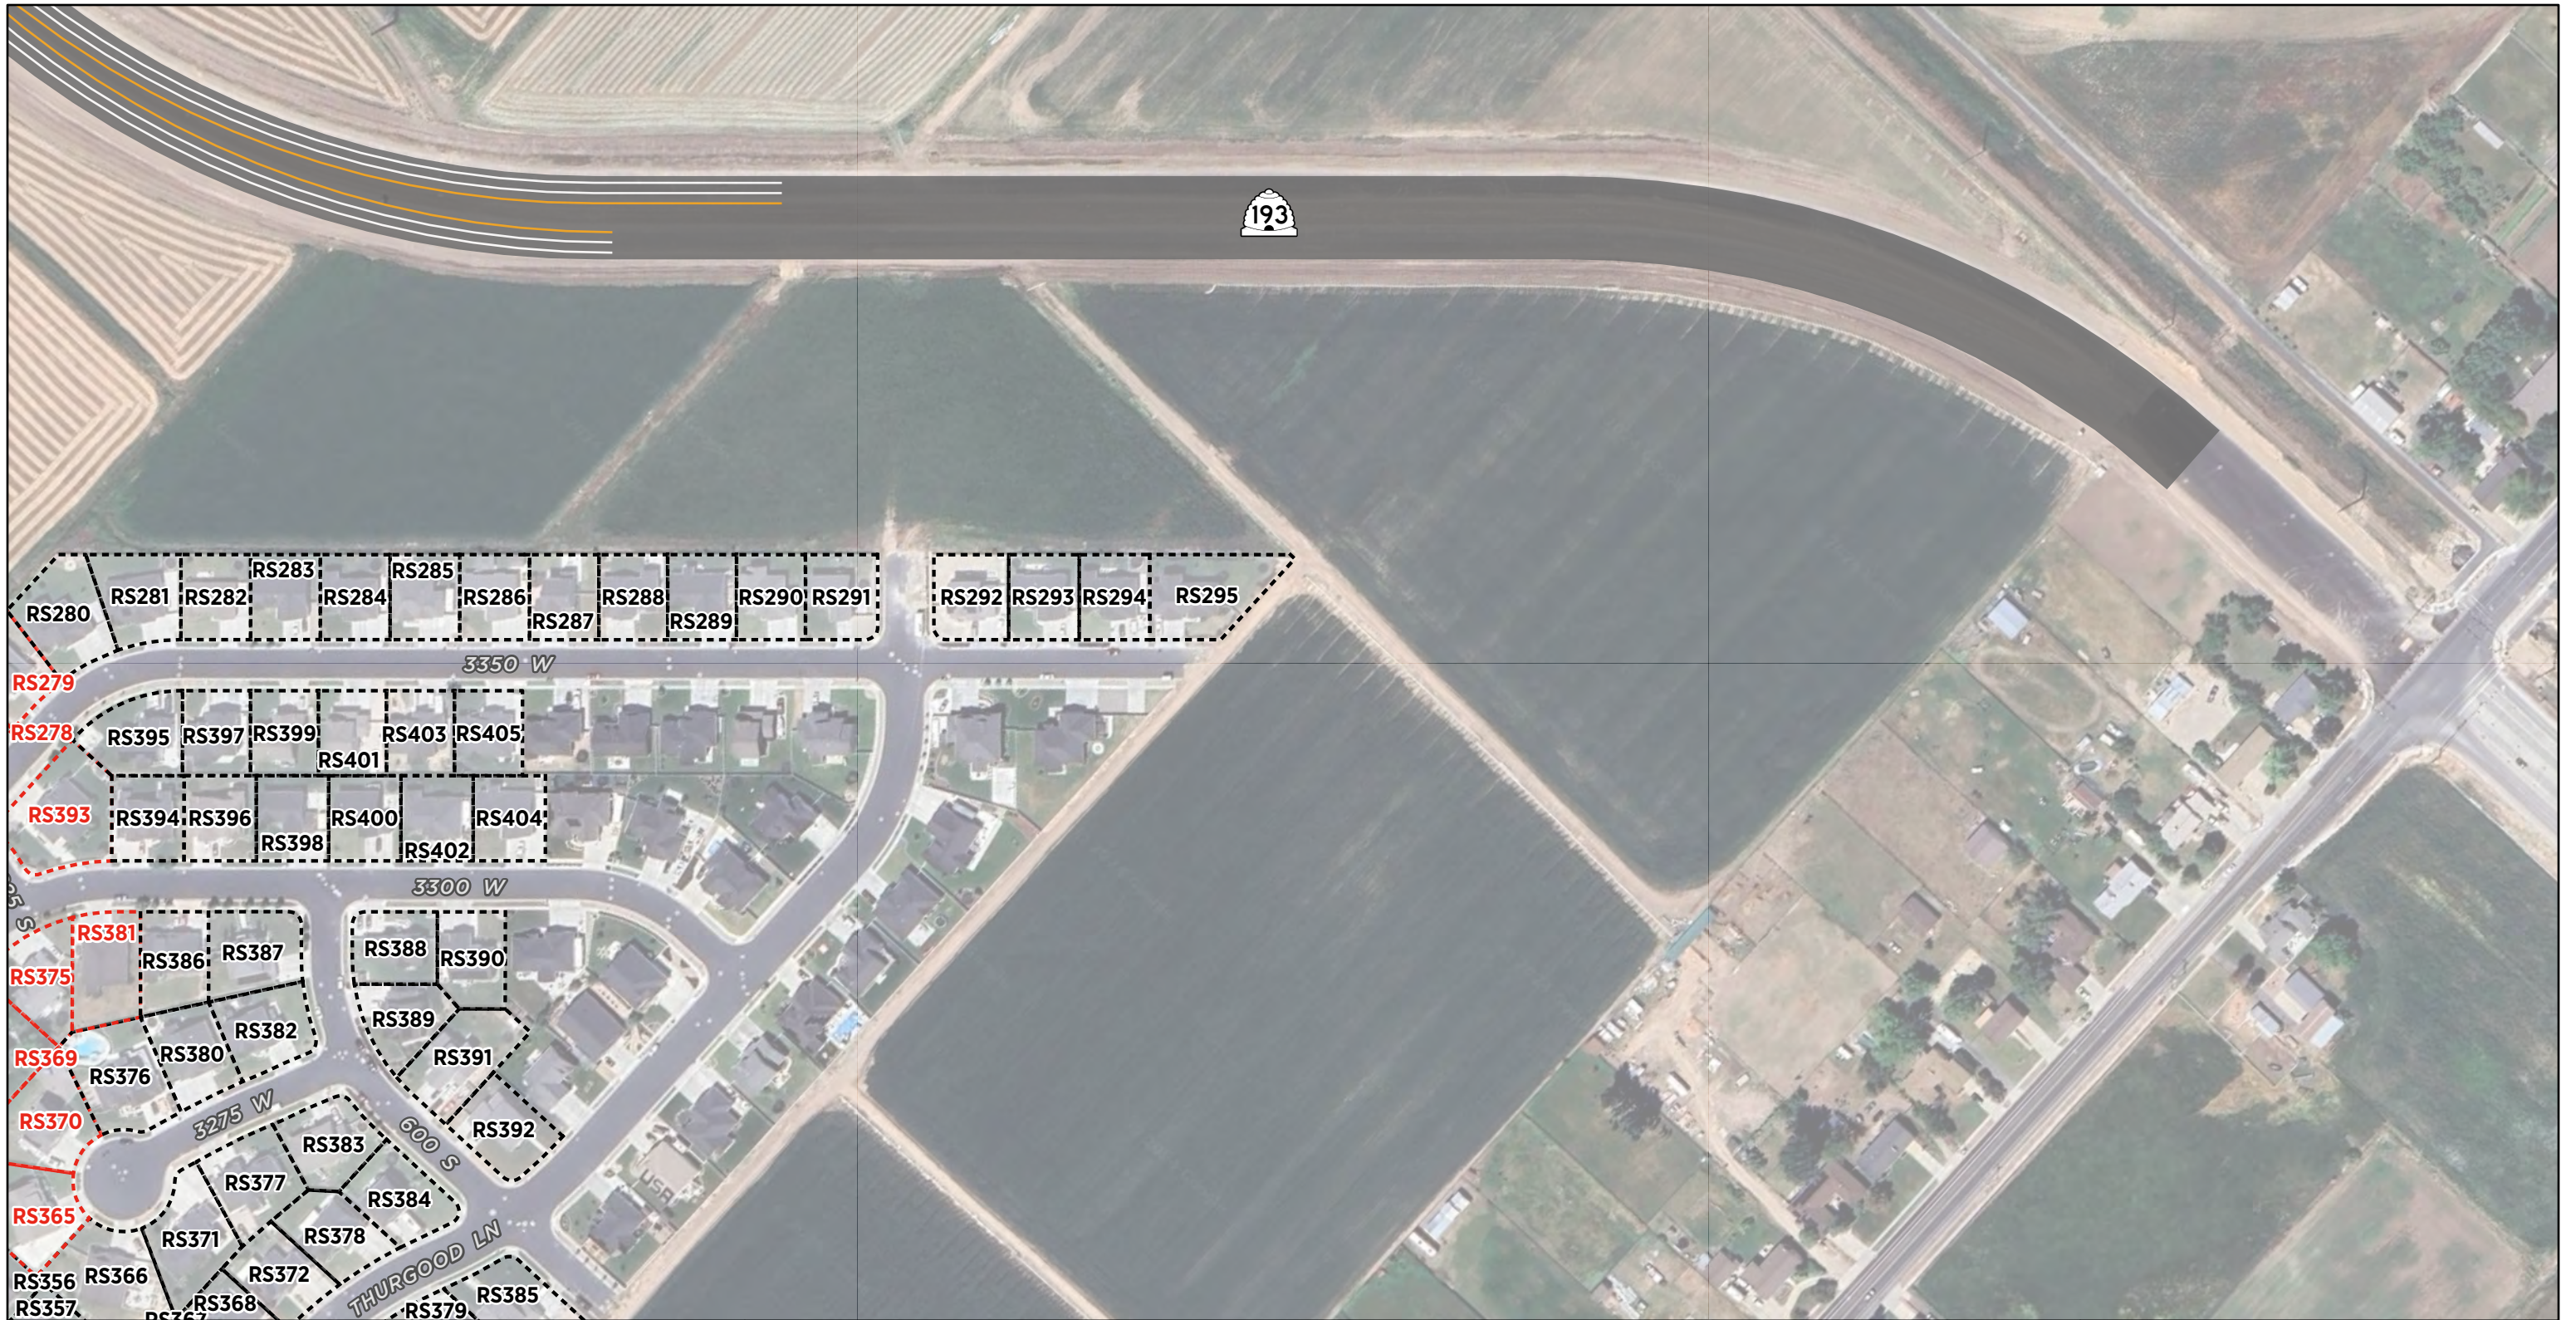
Traffic Noise Study  
Exhibit 1: Noise Receptors  
UDOT Project No.: S-R199(381)  
UDOT PIN: 20927

- Proposed Action Design
- Impacted Receptor
- Receptor Area

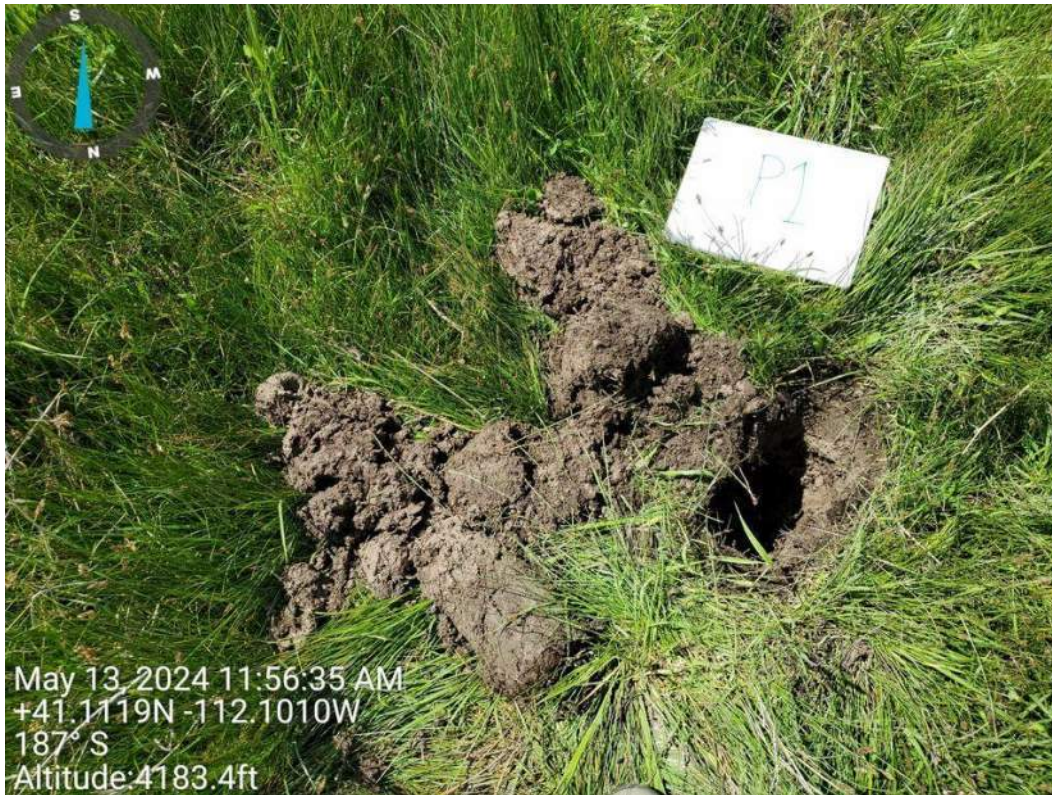
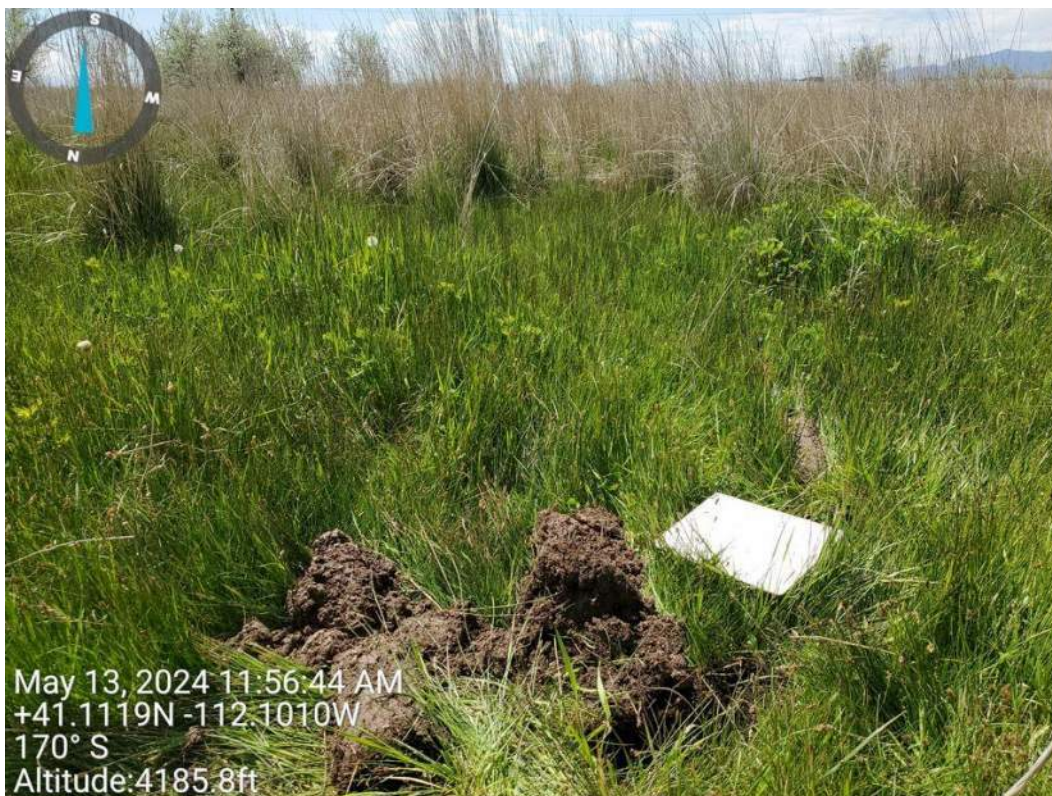
**Sample Point 1**

A higher water table would have likely developed with more time. Conditions of soils were very saturated, likely from a mix of high ground water and surface drainage from local irrigation practices. This area is slightly depressed, allowing this water to permeate the soils while slowly draining to the north.

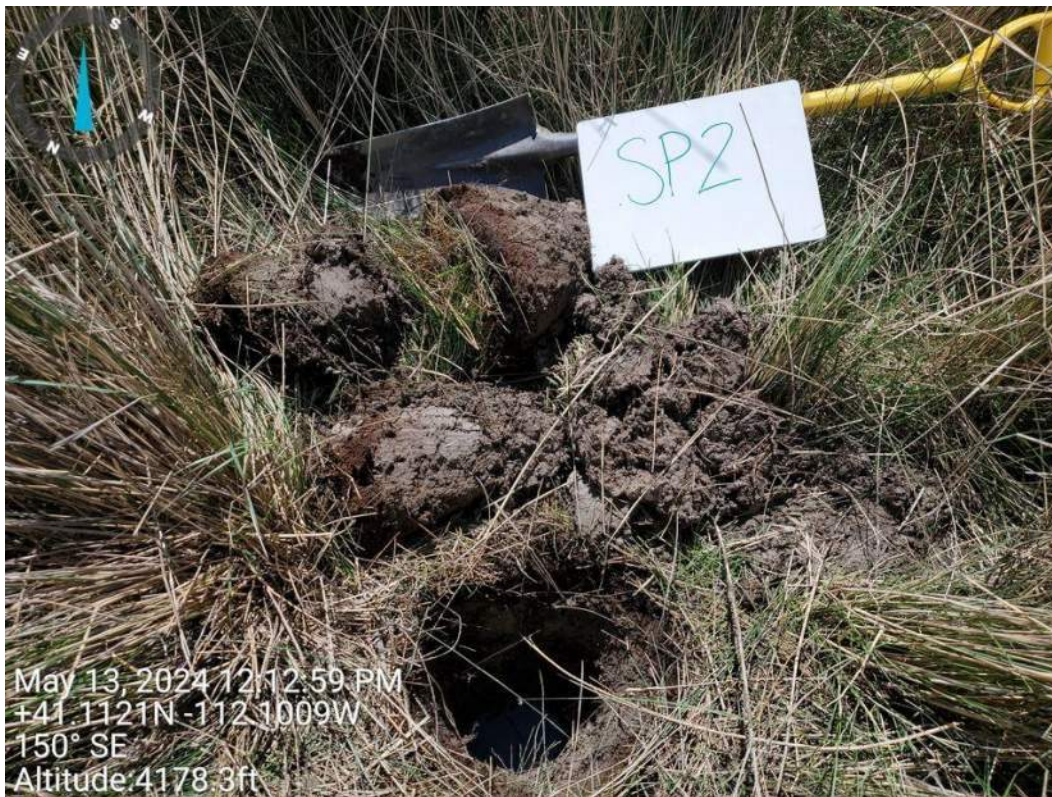
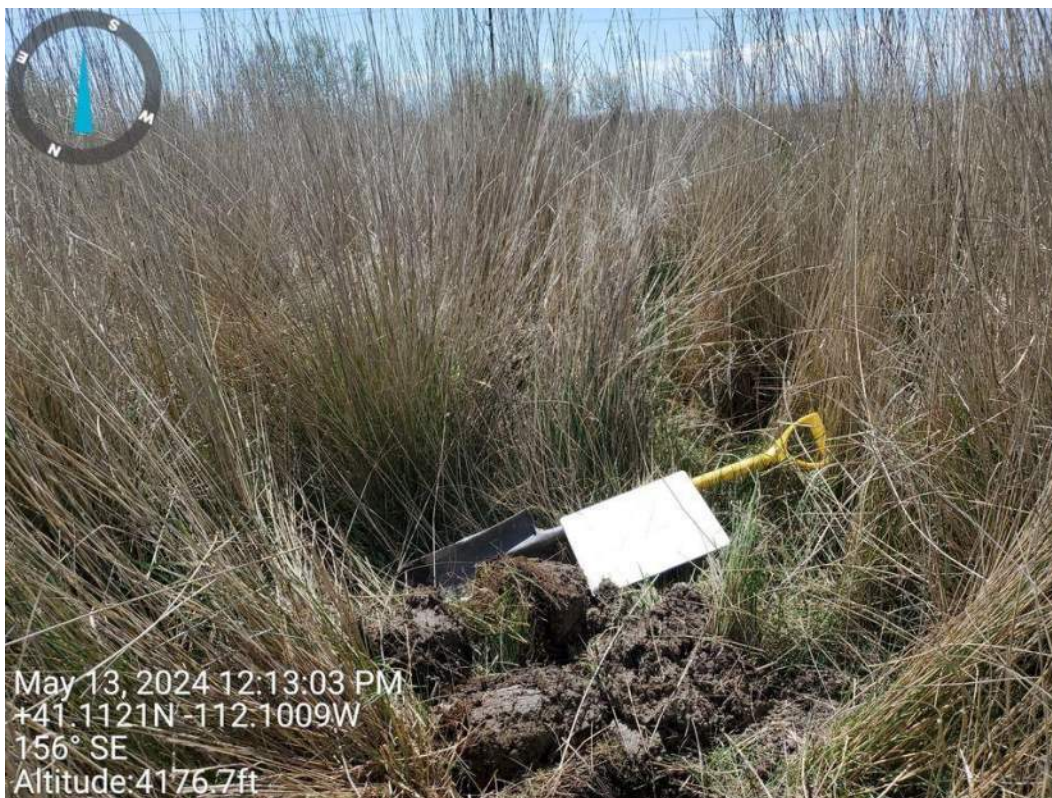
**Sample Point 2**

**Water table present at bottom four inches of sample point pit and soil was moist but not fully saturated to the extent that was present at other points throughout the delineation area except the soils that were close to and under the water table.**

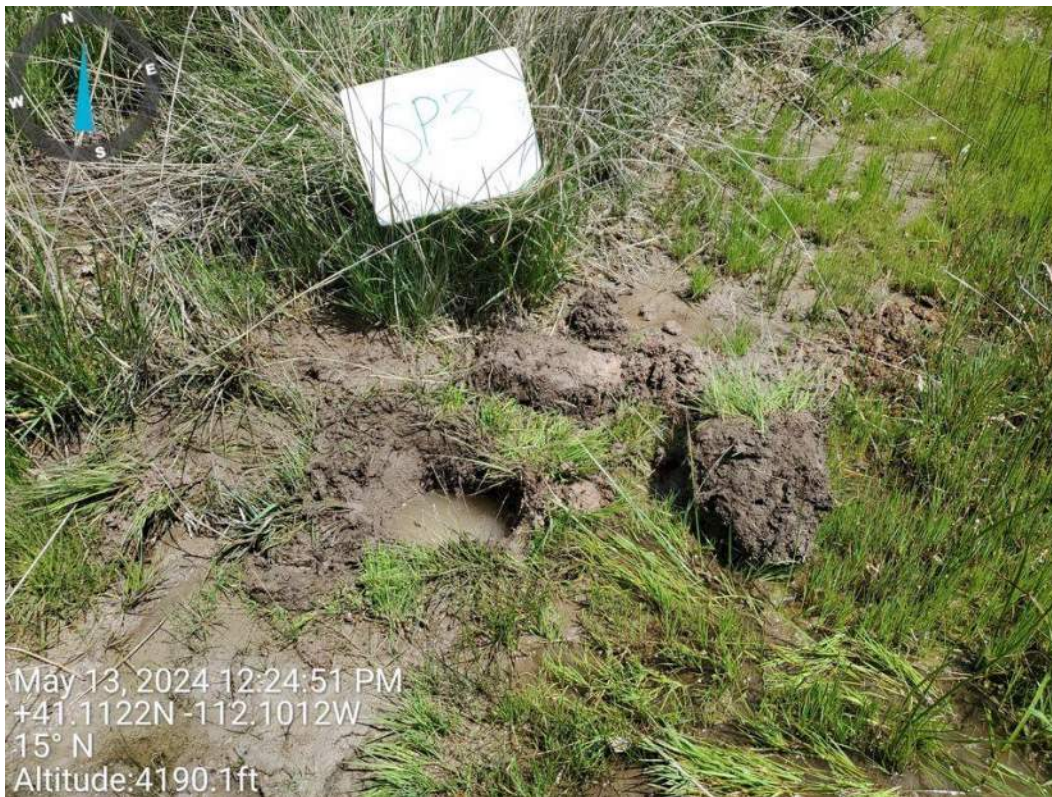
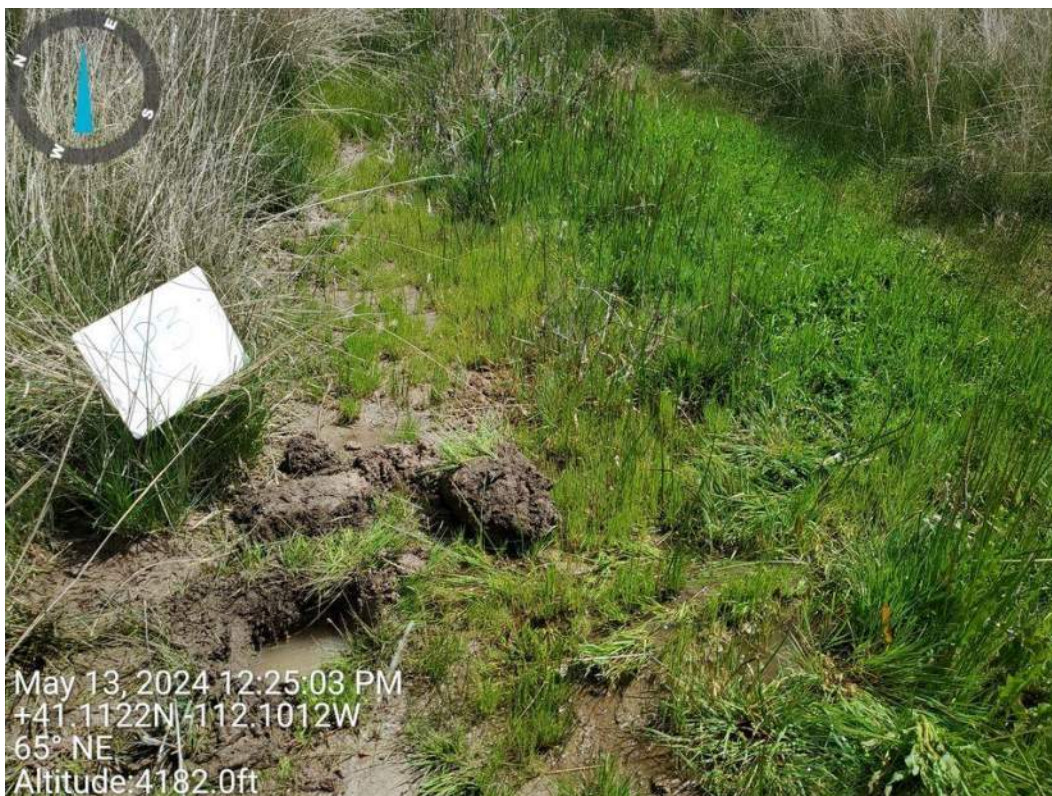
**Sample Point 3**

Some surface water surrounding the sample point pit location was present. Depth was not greater than 3-inches.

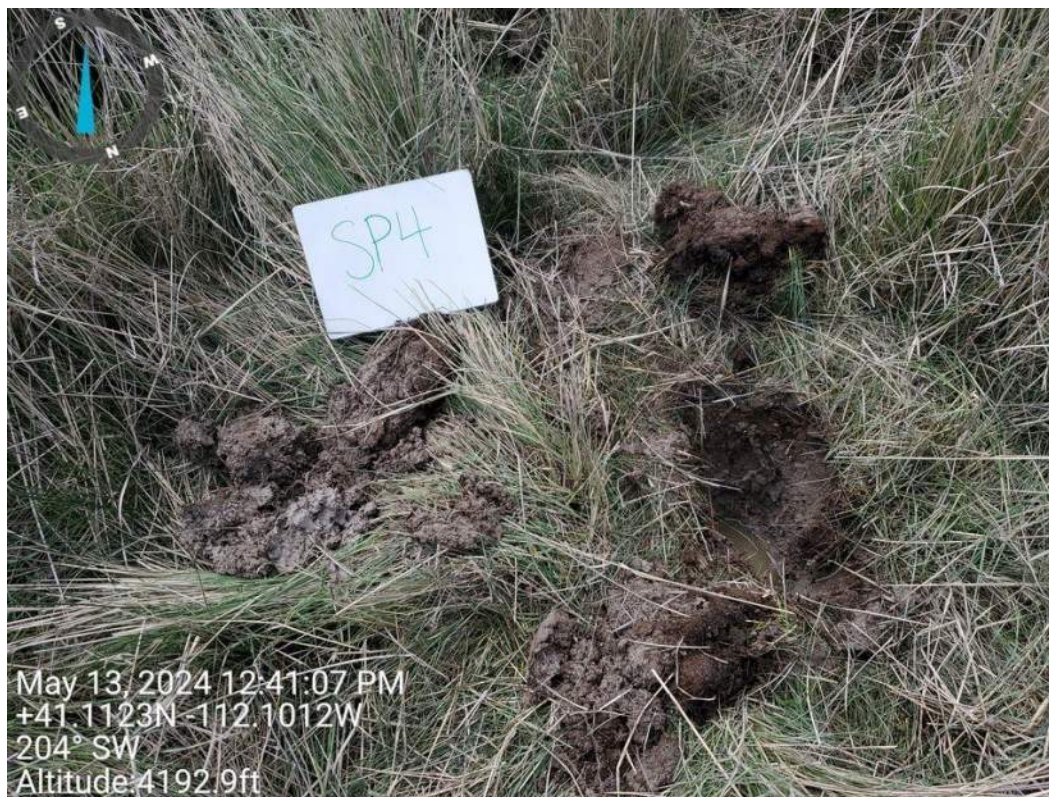
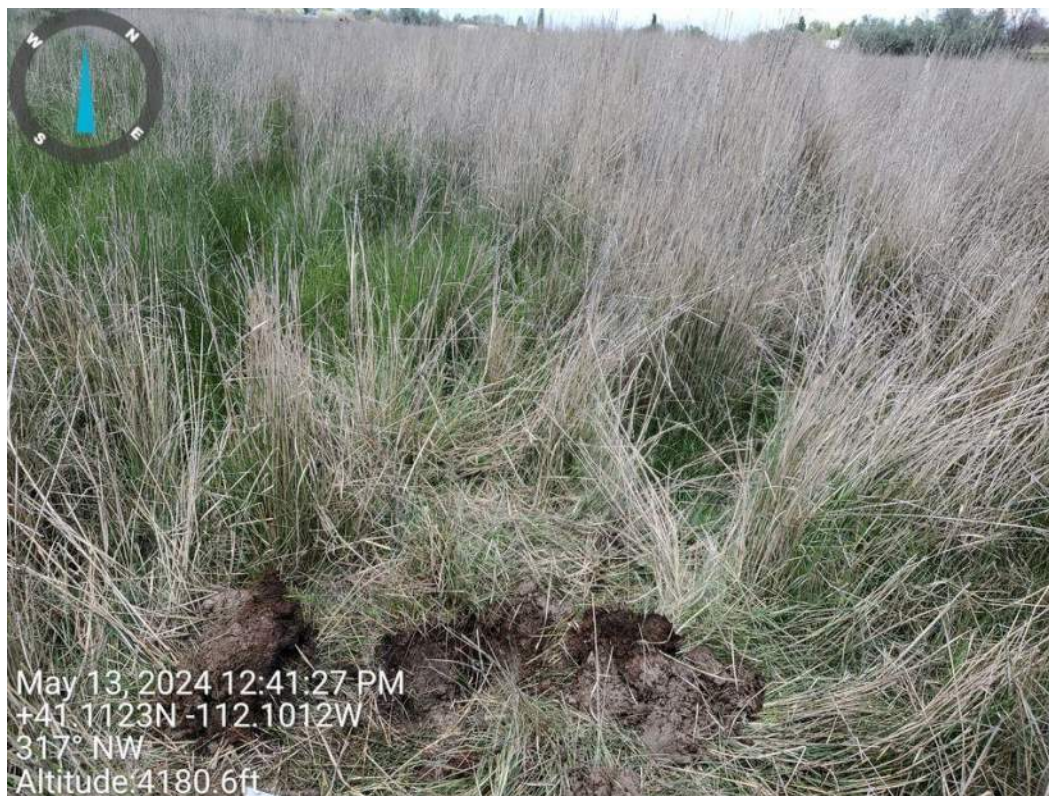
**Sample Point 4**

Water table present at bottom four inches of sample point pit and soil was moist but not fully saturated to the extent that was present at other points throughout the delineation area except the soils that were close to and under the water table.

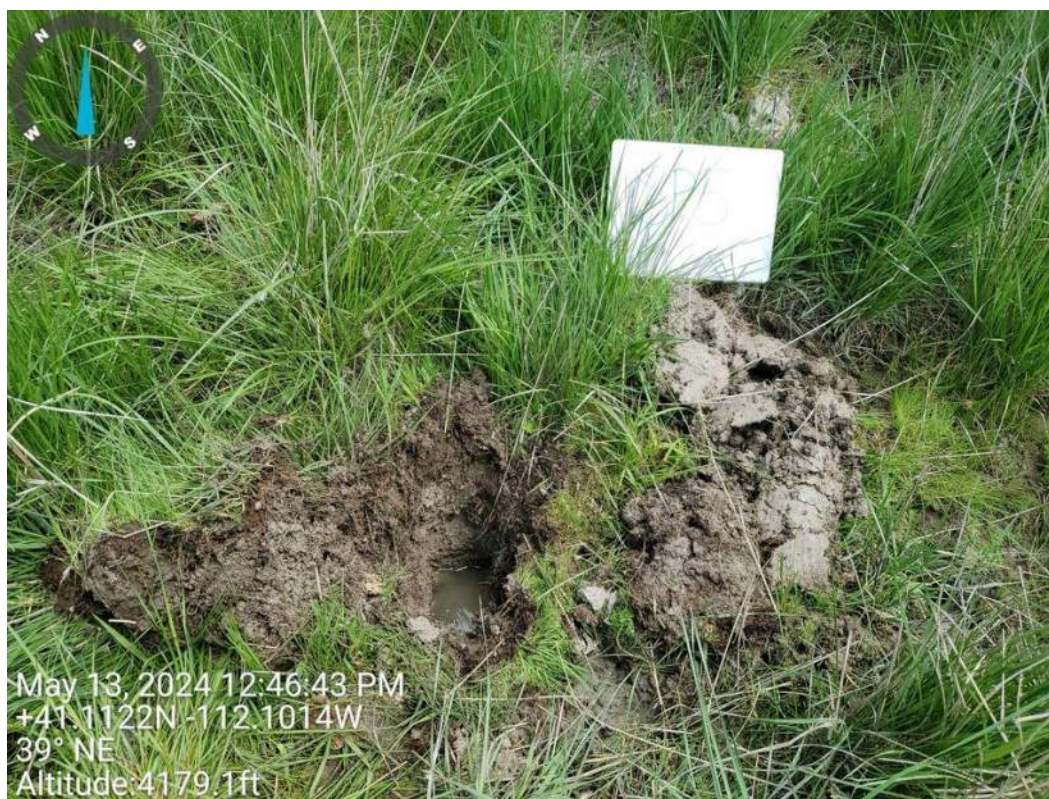
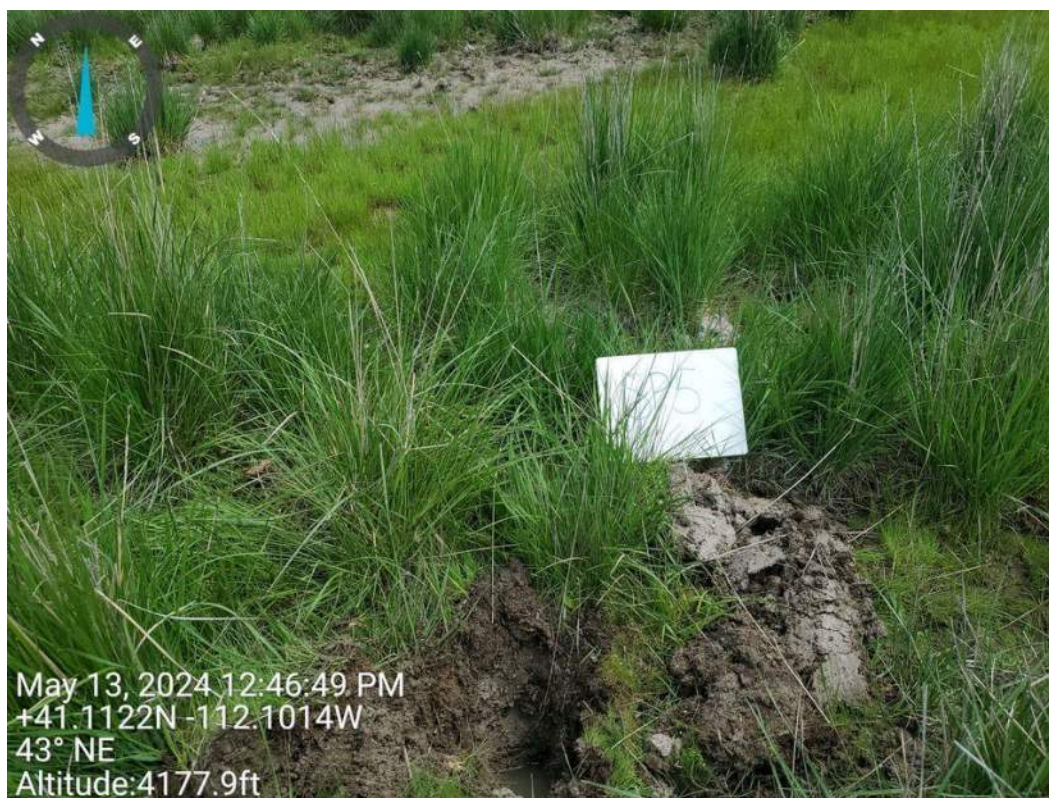
**Sample Point 5**

A higher water table would have likely developed with more time. Conditions of soils were very saturated, likely from a mix of high ground water and surface drainage from local irrigation practices. This area is slightly depressed, allowing this water to permeate the soils while slowly draining to the south.

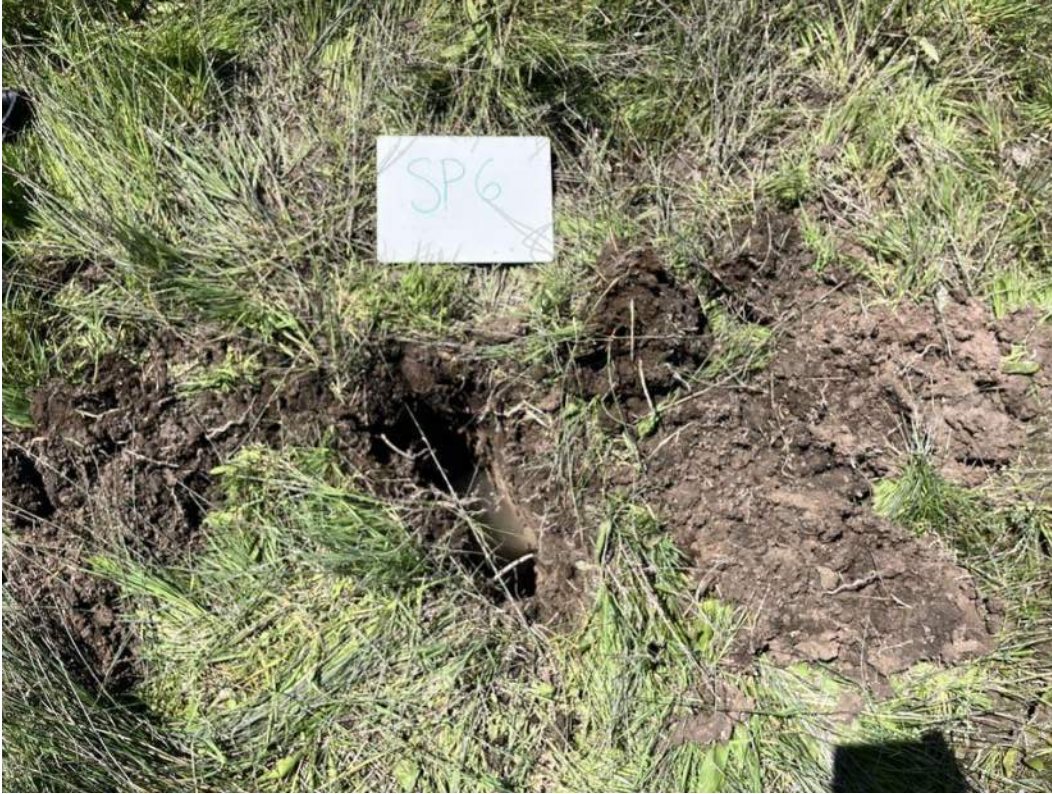
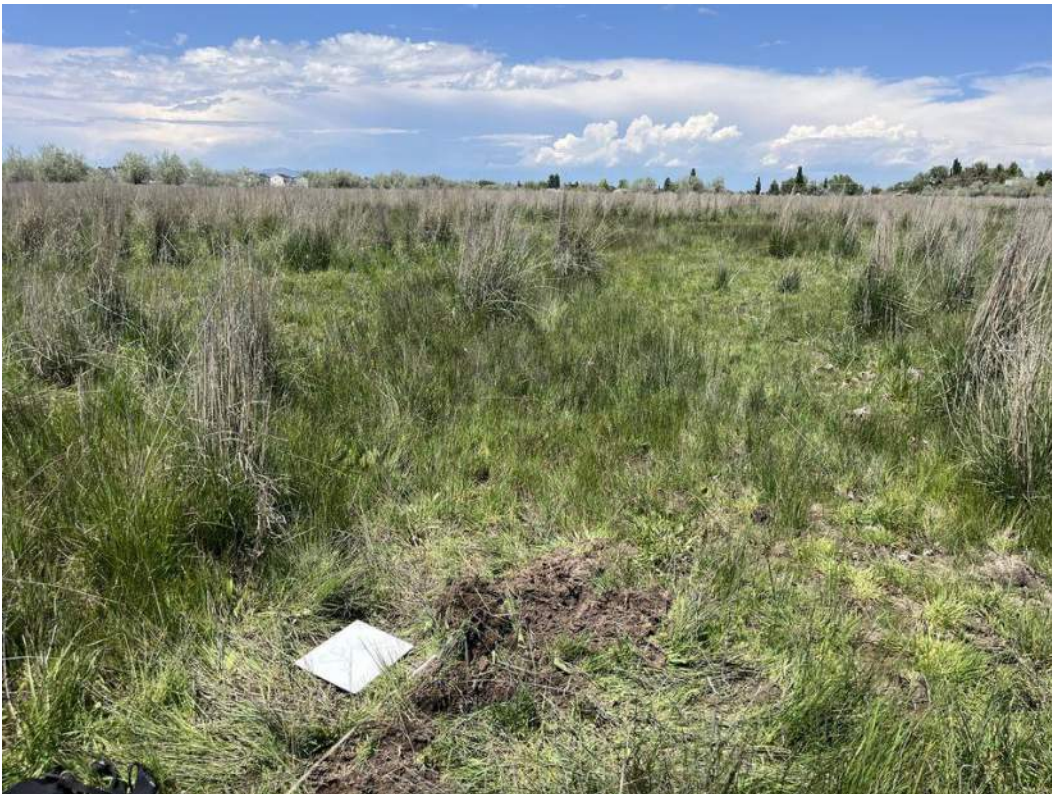
**Sample Point 6**

Water table present at bottom four inches of sample point pit and soil was moist but not fully saturated to the extent that was present at other points throughout the delineation area except the soils that were close to and under the water table.

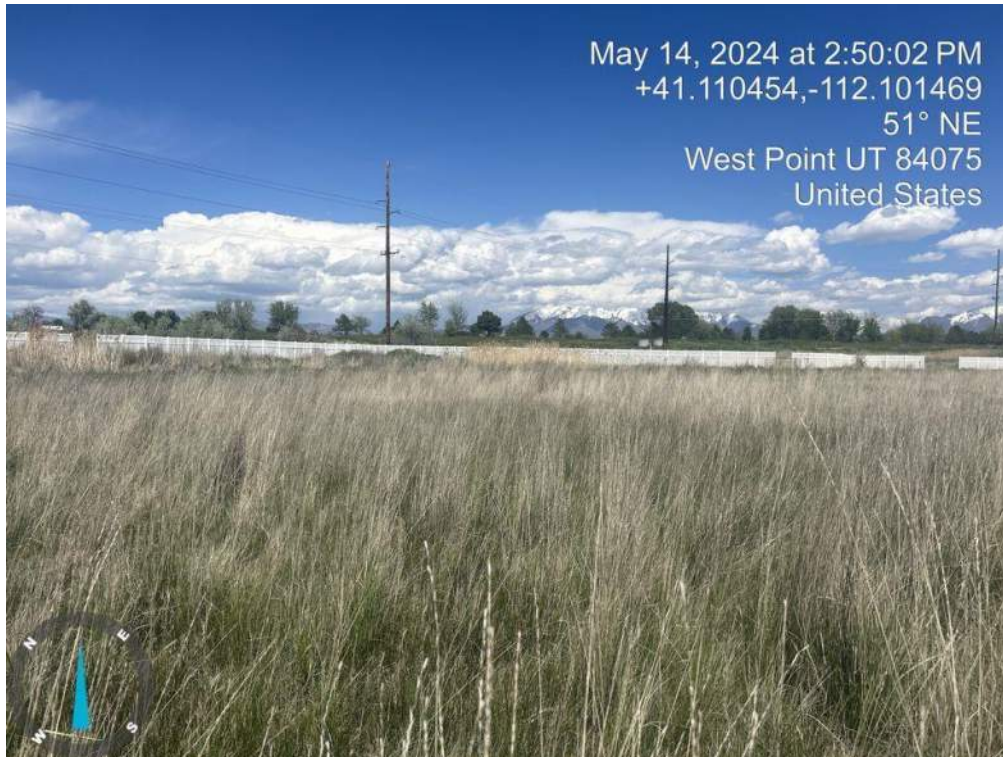
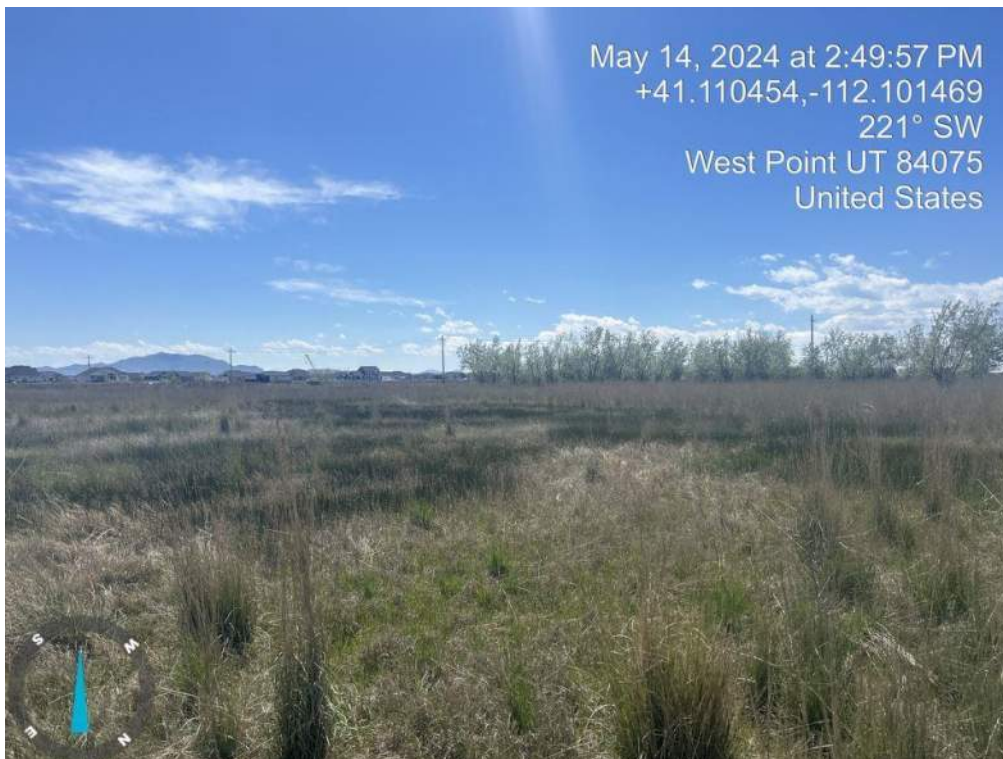
**Sample Point 23 – Wetland area photos taken at sample point location,  
neglected to take photos of sample**

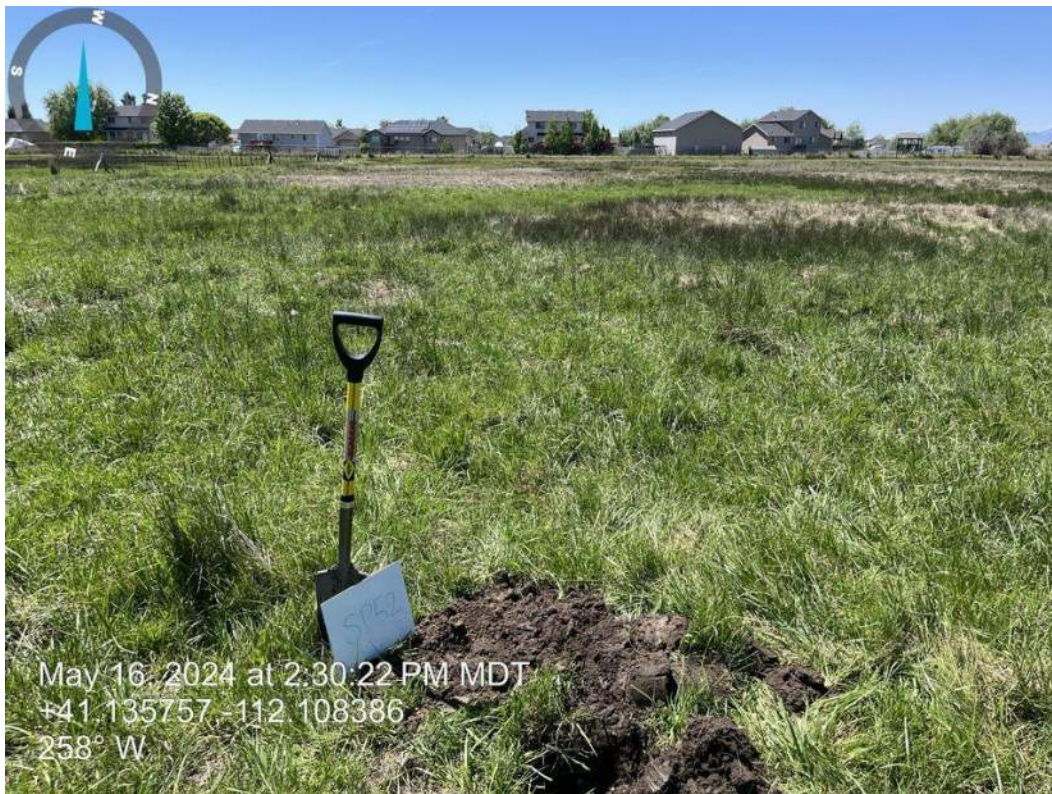
**Sample Point 52**

Hydrophytic Vegetation Present?	Yes <input checked="" type="checkbox"/>	No _____	Is the Sampled Area within a Wetland?	Yes <input checked="" type="checkbox"/> No _____
Hydric Soil Present?	Yes <input checked="" type="checkbox"/>	No _____		
Wetland Hydrology Present?	Yes <input checked="" type="checkbox"/>	No _____		
Remarks: Conditions were wetter than normal according to the antecedent precipitation tool, but there had not been rain for several days prior to the site visit. Pasture grazed by goats. Appears to be ponding of high ground water in middle of goat pen, which saturates much of the area before draining through a culvert to the adjacent pond.

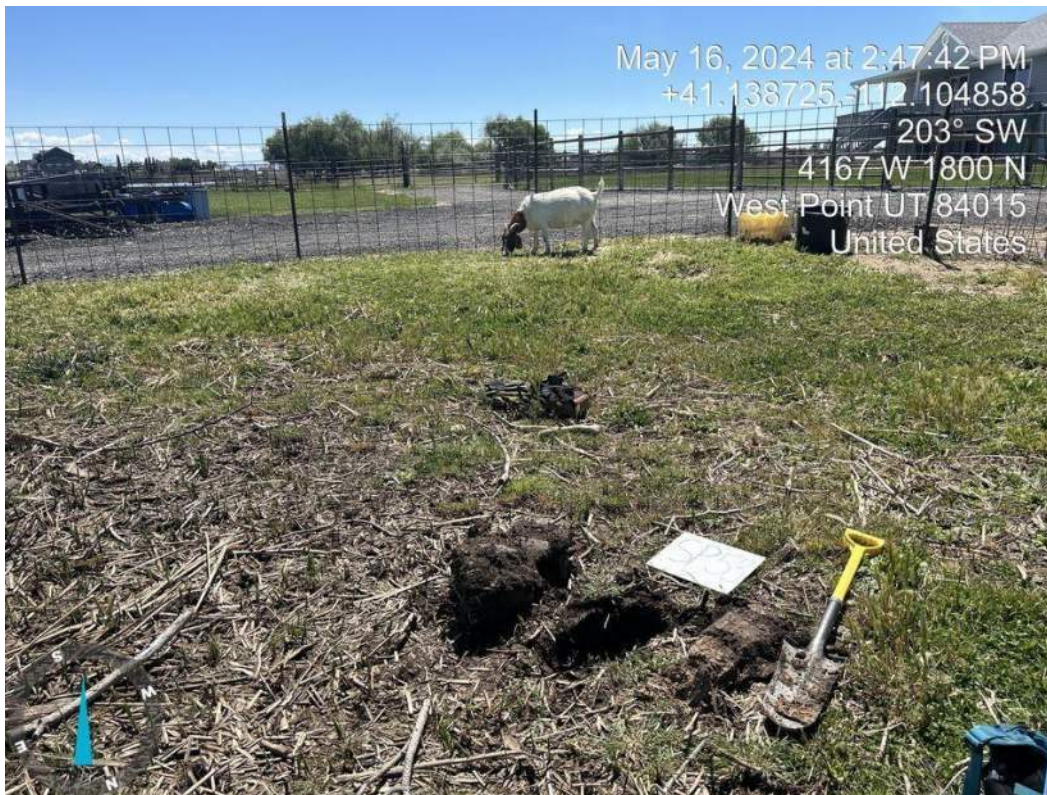
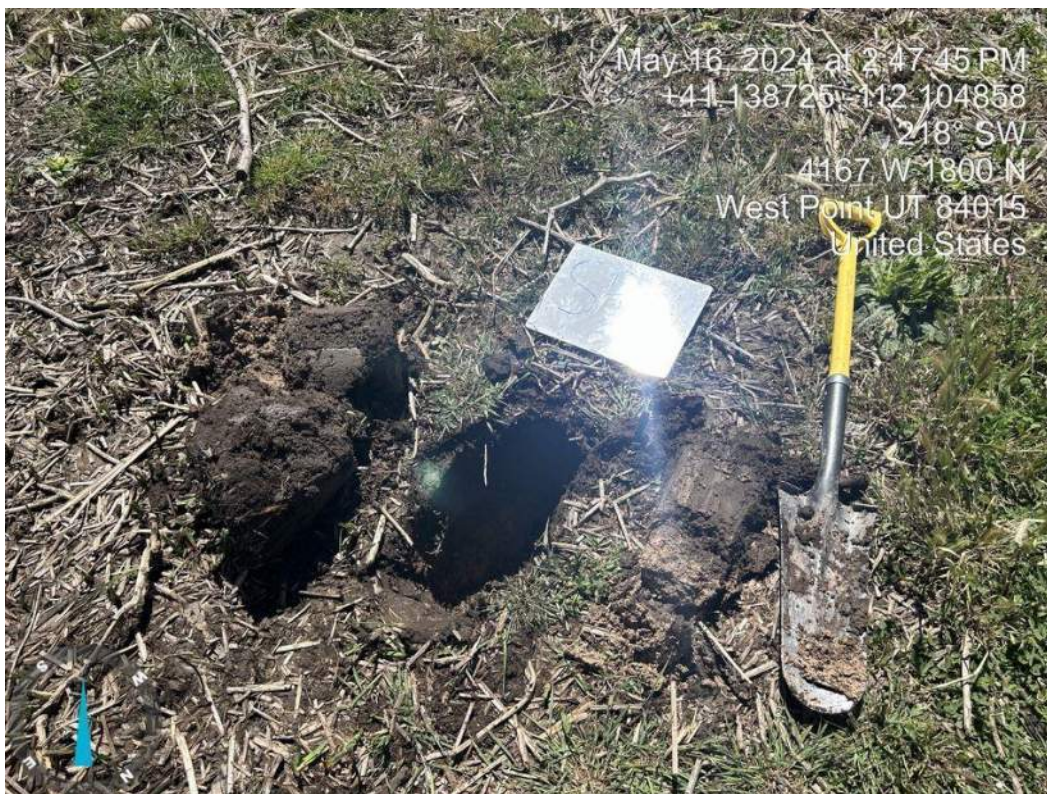
**Sample Point 53**

Hydrophytic Vegetation Present? Yes _____ No <input checked="" type="checkbox"/>	Is the Sampled Area within a Wetland? Yes _____ No <input checked="" type="checkbox"/>
Hydric Soil Present? Yes _____ No <input checked="" type="checkbox"/>	
Wetland Hydrology Present? Yes _____ No <input checked="" type="checkbox"/>	
Remarks: Conditions were wetter than normal according to the antecedent precipitation tool, but there had not been rain for several days prior to the site visit. Pasture grazed by goats. Sample point was taken on edge of pasture where grade raised at the fence line.

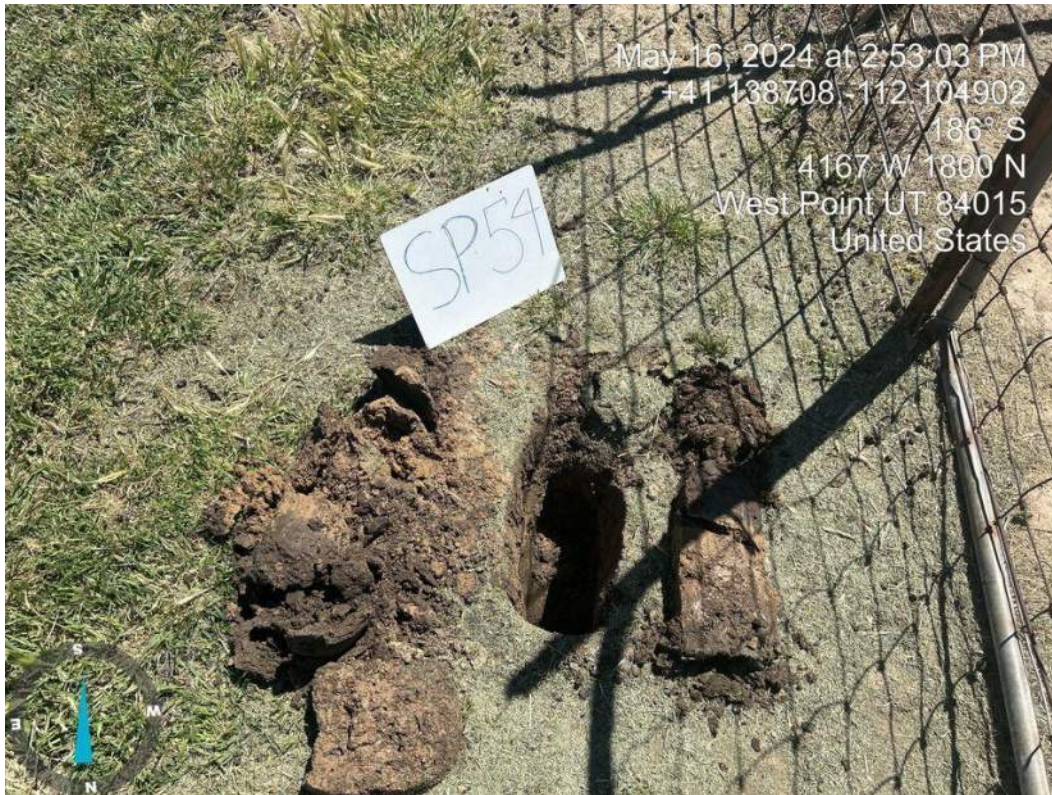
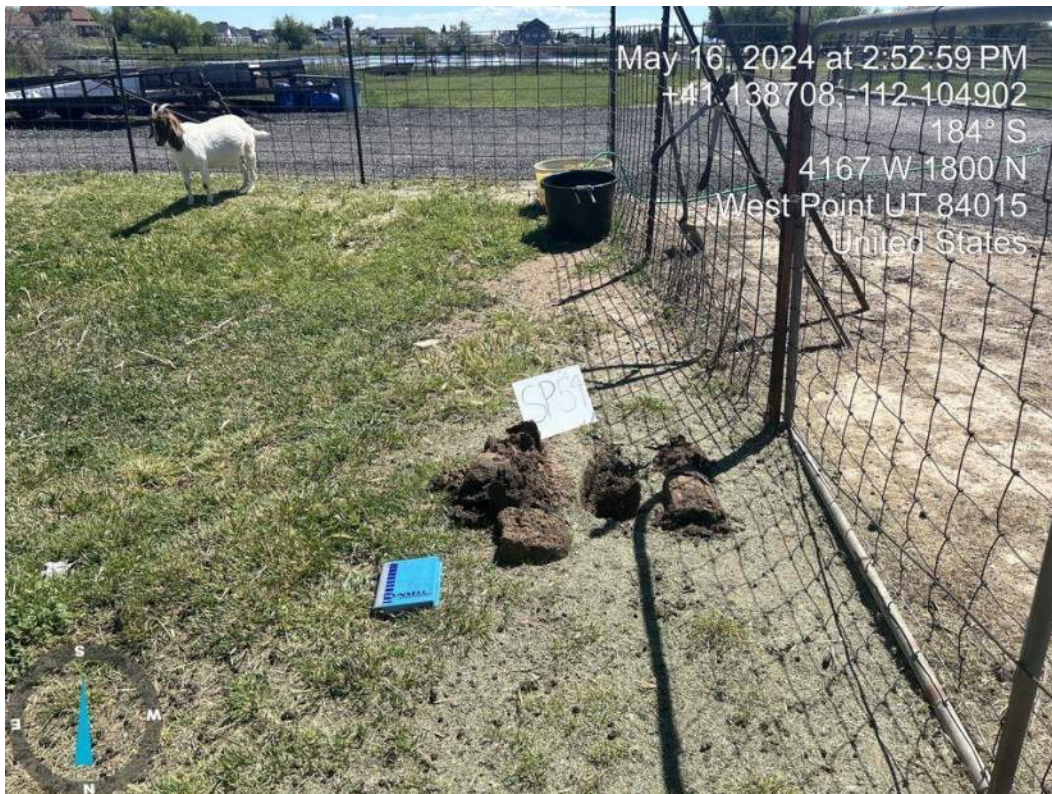
**Sample Point 54**

Hydrophytic Vegetation Present? Yes <input checked="" type="checkbox"/> No _____	Is the Sampled Area within a Wetland? Yes _____ No <input checked="" type="checkbox"/>
Hydric Soil Present? Yes _____ No <input checked="" type="checkbox"/>	
Wetland Hydrology Present? Yes _____ No <input checked="" type="checkbox"/>	
Remarks: Conditions were wetter than normal according to the antecedent precipitation tool, but there had not been rain for several days prior to the site visit. Hydrophytic vegetation likely grows due to the small depression where water drains and temporarily collects from wetlands upslope. This area does not have indicators for wetland soils or hydrology and does not qualify as a wetland.

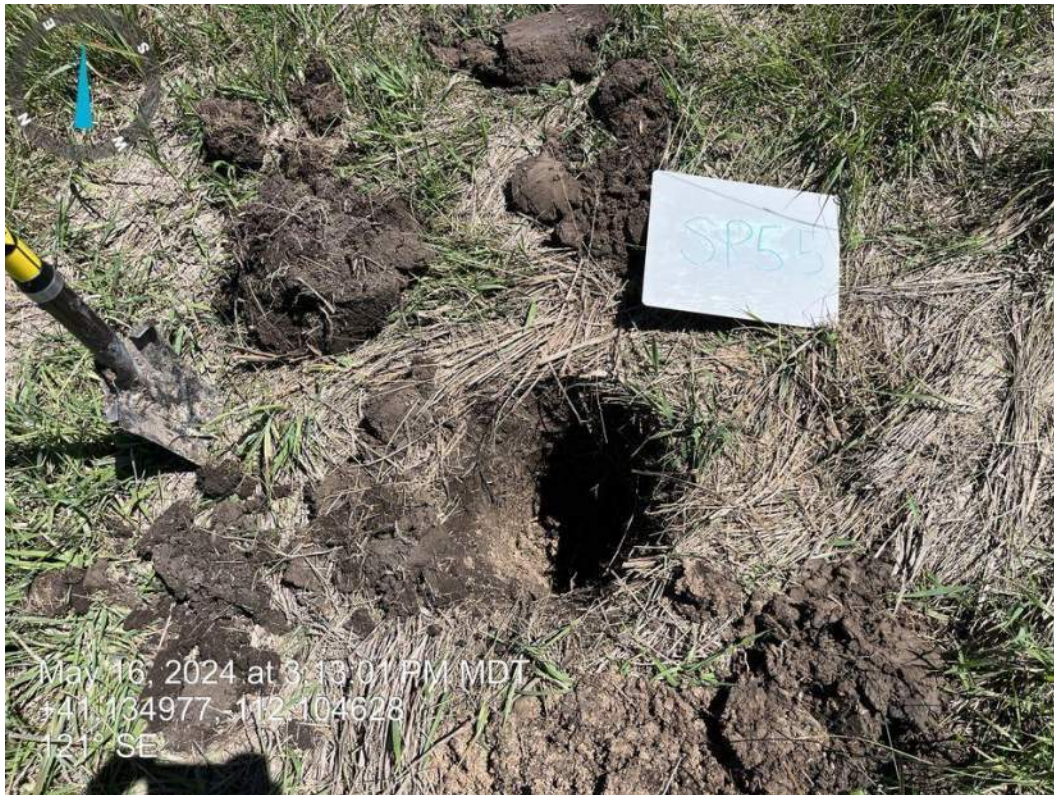
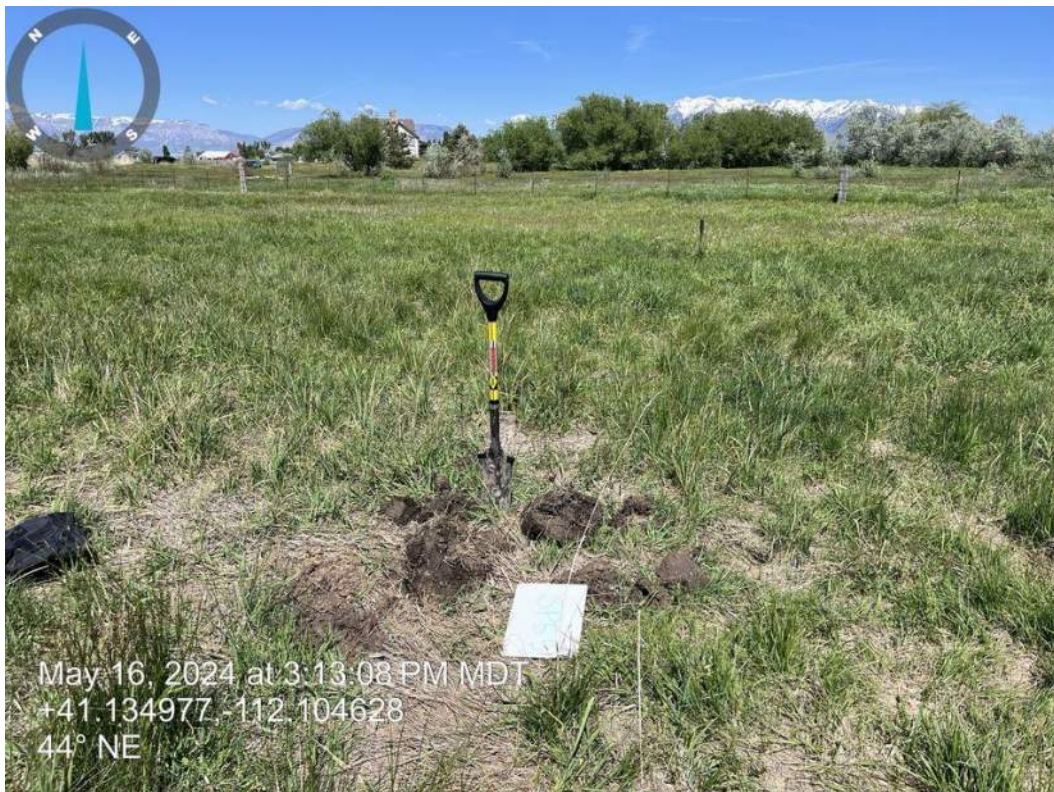
**Sample Point 55**

Hydrophytic Vegetation Present? Yes <input checked="" type="checkbox"/> No _____	Is the Sampled Area within a Wetland? Yes <input checked="" type="checkbox"/> No _____
Hydric Soil Present? Yes <input checked="" type="checkbox"/> No _____	
Wetland Hydrology Present? Yes <input checked="" type="checkbox"/> No _____	
Remarks:  Conditions were wetter than normal according to the antecedent precipitation tool, but there had not been rain for several days prior to the site visit. Gradual sloping meadow towards pond.
