## DEPARTMENT OF TRANSPORTATION

SUBJECT: UDOT Project Number S-R199 (381)  
SR-177; SR-193 to 1800 N. (PIN 20927)  
*Environmental Impact Statement Re-evaluation 15*

Traffic Noise Study

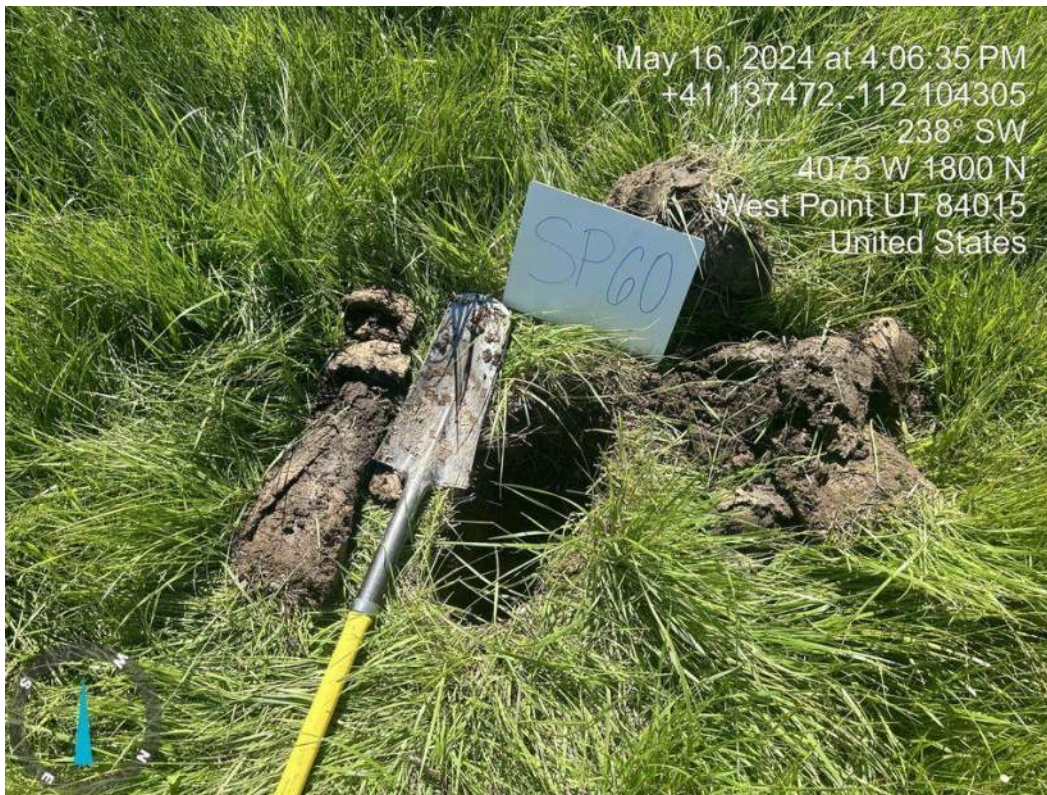
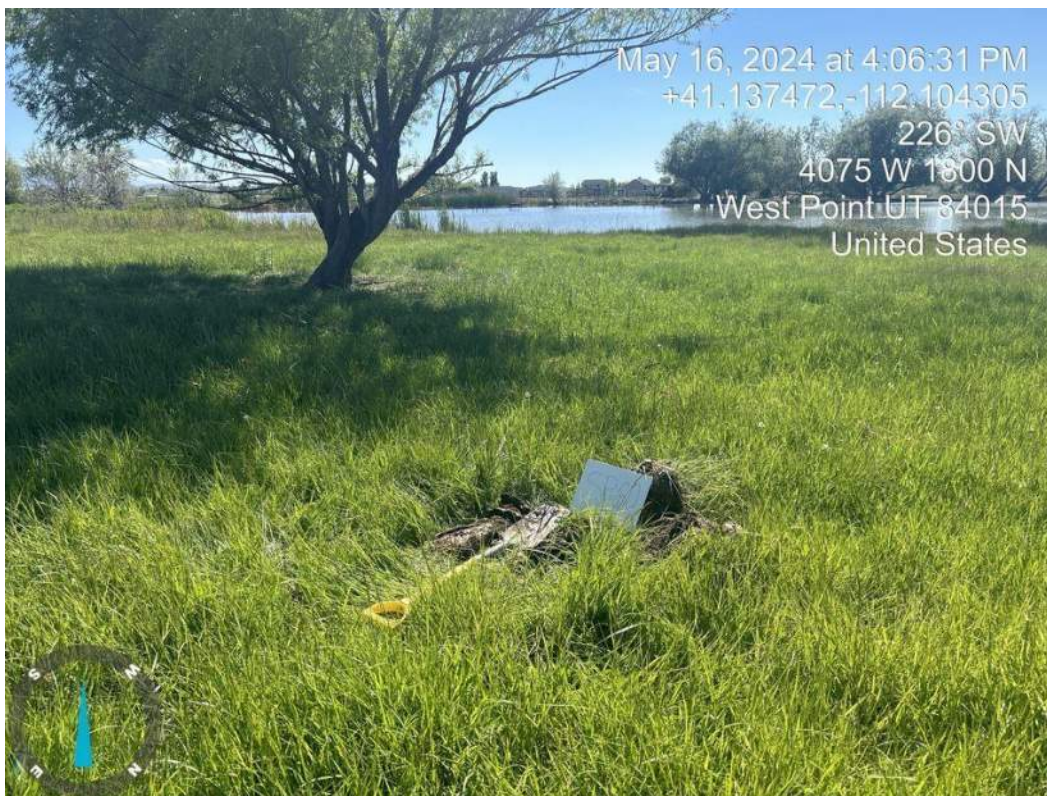
**Sample Point 60**

**More surface water at the center of the wetland with cattail growth.**

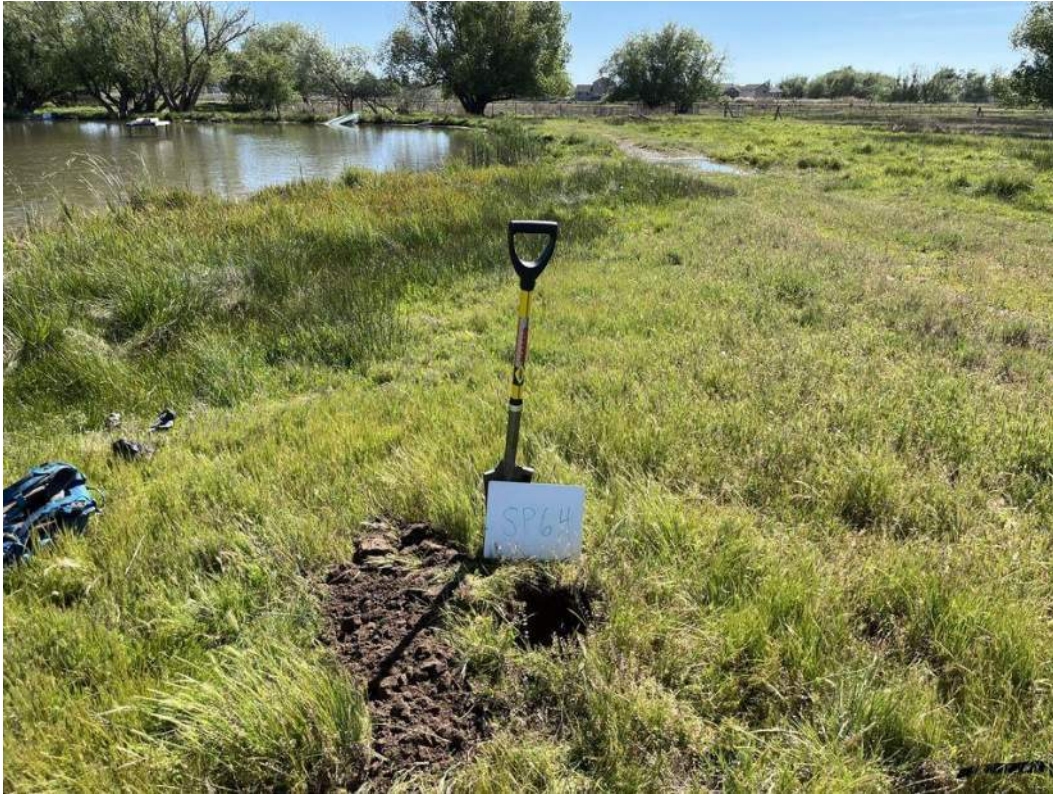
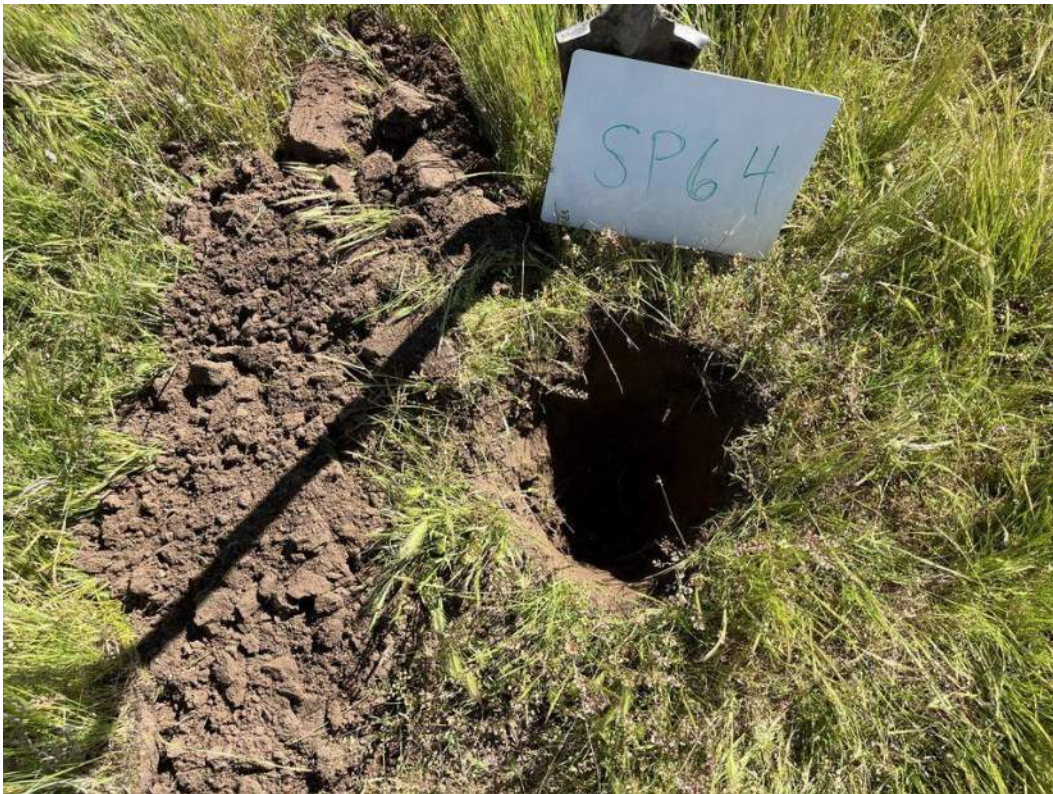
**Sample Point 64**

**Inundated and saturated from irrigation ditch overflow. Likely dry at different time of year.**

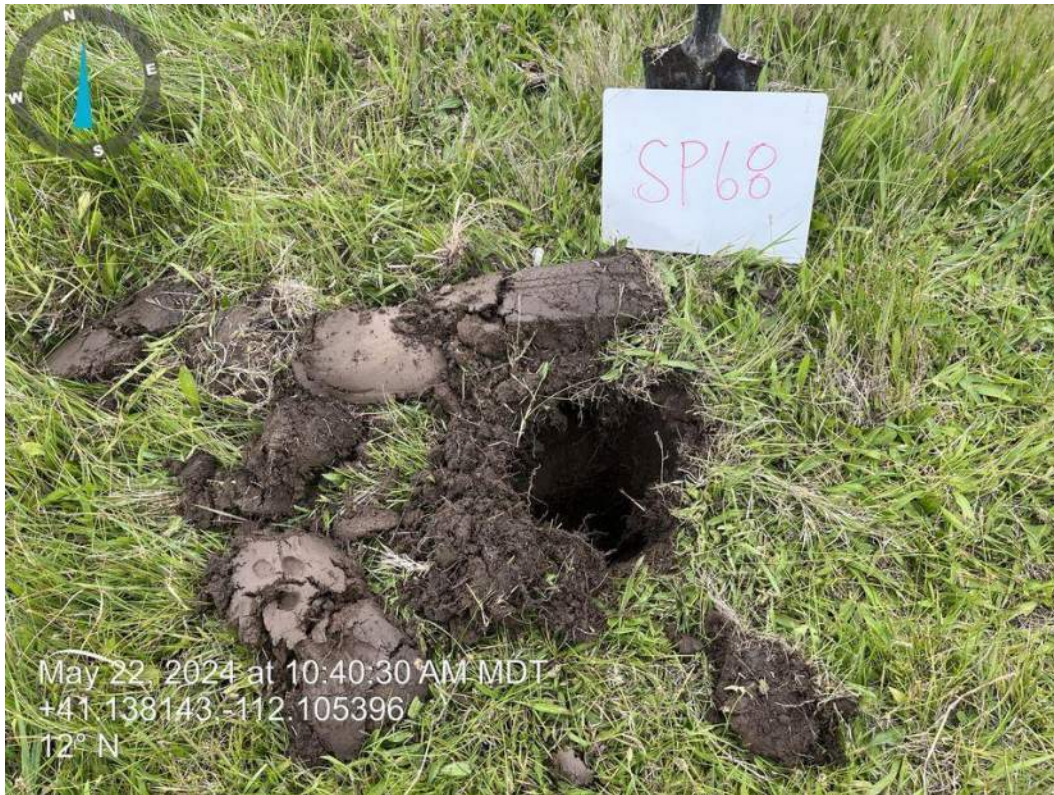
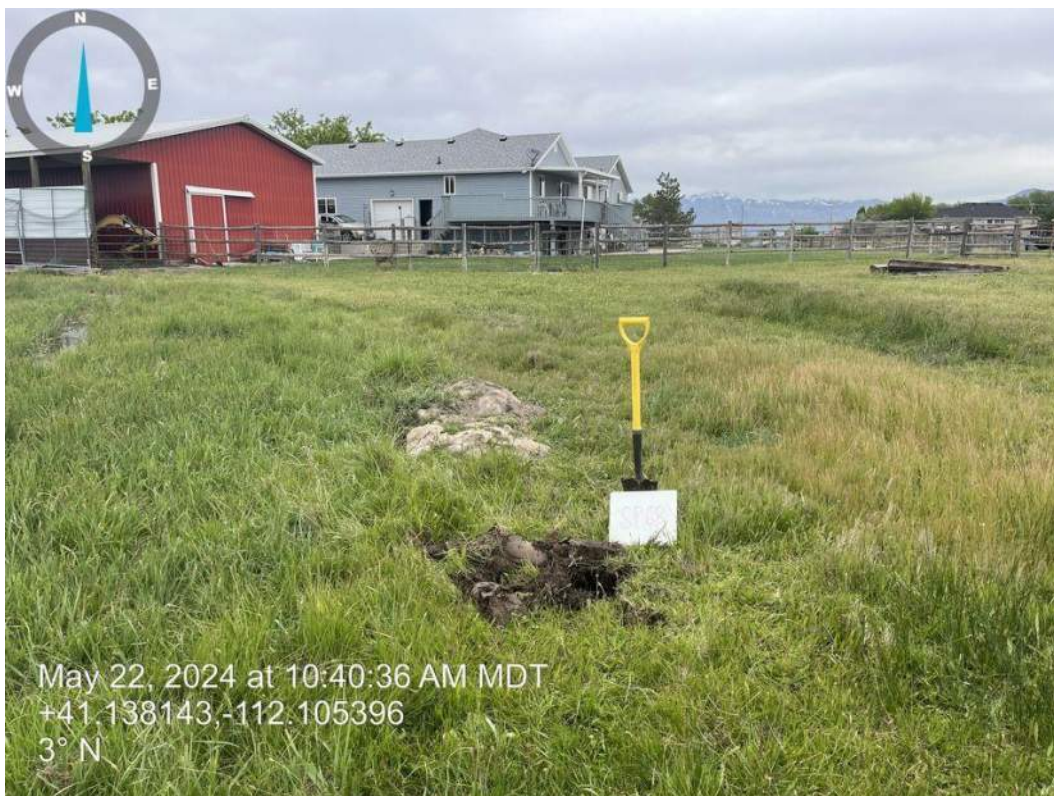
**Sample Point 68**

Between two overflowing irrigation ditches but more sedges than other places.

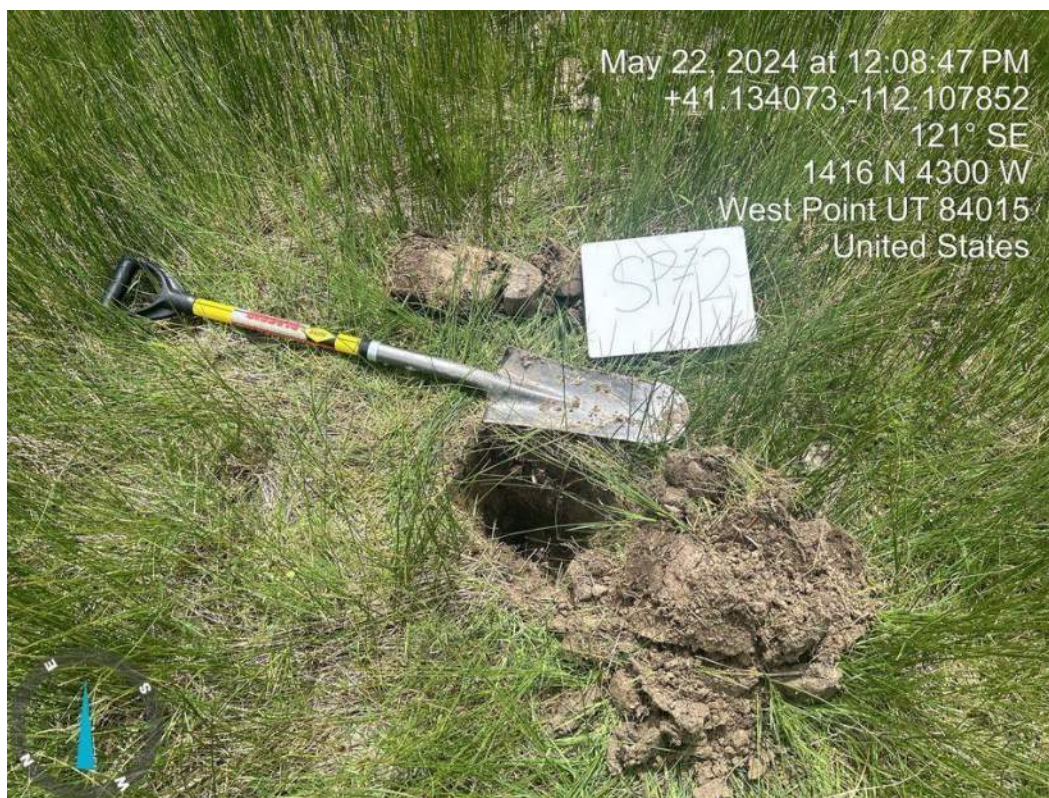
**Sample Point 72**

Hydrophytic Vegetation Present? Yes _____ No <input checked="" type="checkbox"/>	Is the Sampled Area within a Wetland? Yes _____ No <input checked="" type="checkbox"/>
Hydric Soil Present? Yes _____ No <input checked="" type="checkbox"/>	
Wetland Hydrology Present? Yes _____ No <input checked="" type="checkbox"/>	
Remarks:  Conditions were wetter than normal according to the antecedent precipitation tool, but there had not been rain for several days prior to the site visit.

Depth (inches)	Matrix		Redox Features				Texture	Remarks
	Color (moist)	%	Color (moist)	%	Type <sup>1</sup>	Loc <sup>2</sup>		
0 - 6	10YR 3/2	100					Clay Loam	
-								
-								
-								
-								
-								
-								
-								
-

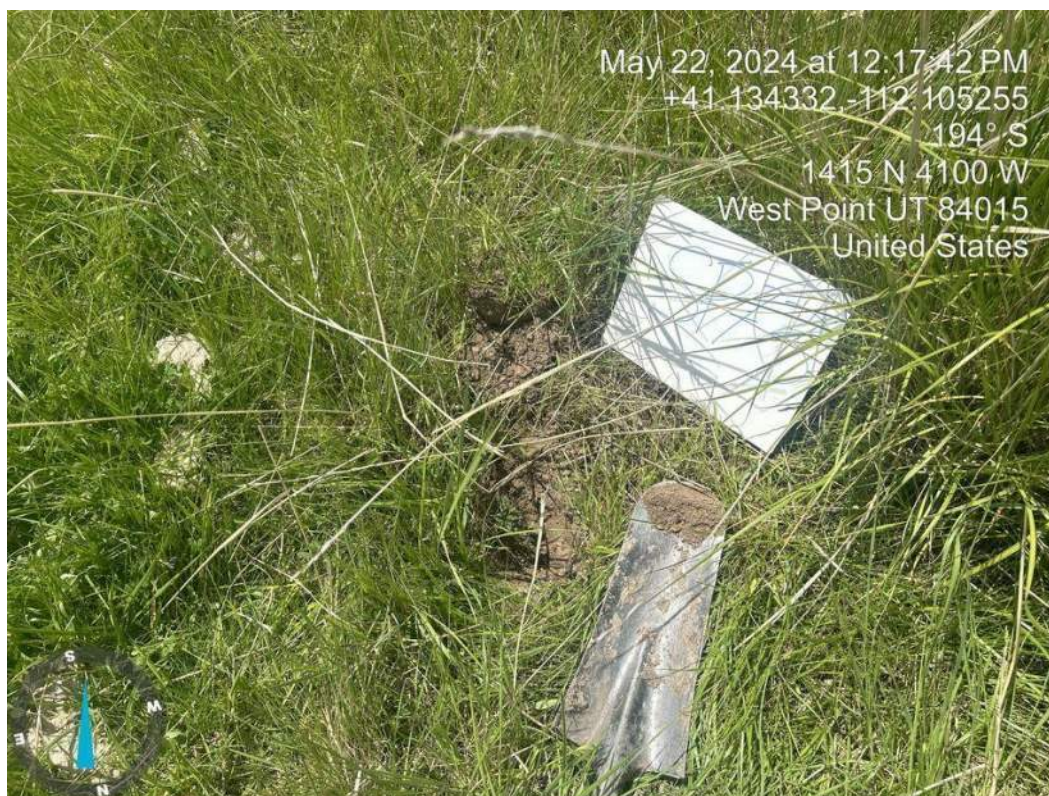
**Sample Point 73**

Hydrophytic Vegetation Present? Yes _____ No <input checked="" type="checkbox"/>	Is the Sampled Area within a Wetland? Yes _____ No <input checked="" type="checkbox"/>
Hydric Soil Present? Yes _____ No <input checked="" type="checkbox"/>	
Wetland Hydrology Present? Yes _____ No <input checked="" type="checkbox"/>	
Remarks: Conditions were wetter than normal according to the antecedent precipitation tool, but there had not been rain for several days prior to the site visit.

Depth (inches)	Matrix		Redox Features				Texture	Remarks
	Color (moist)	%	Color (moist)	%	Type <sup>1</sup>	Loc <sup>2</sup>		
0 - 5	10YR 3/2	100					Silty Clay Loam	
5 - 18	10YR 4/3	100					Silty Clay	
18 - 28	10YR 4/3	100					Clay	
-								
-								
-								
-								
-

**Saturation must be within 12" of soil surface to be an indicator of hydrology. No hydrology present.**

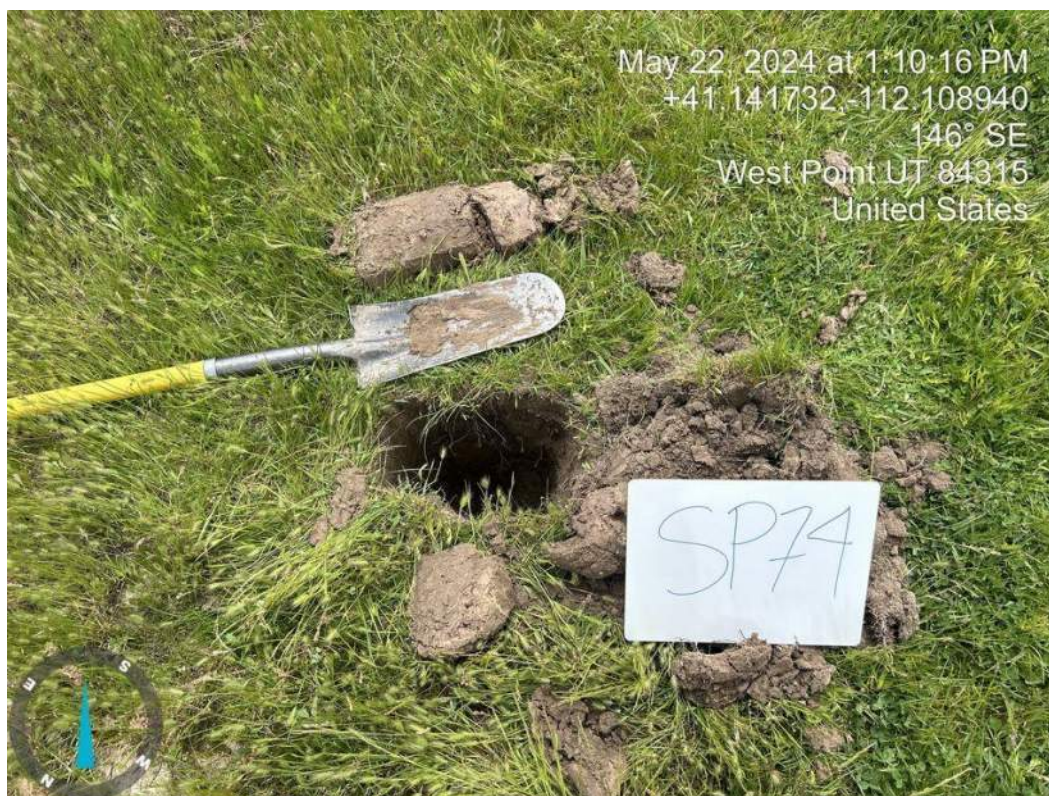
**Sample Point 74**

Hydrophytic Vegetation Present? Yes _____ No <input checked="" type="checkbox"/>	Is the Sampled Area within a Wetland? Yes _____ No <input checked="" type="checkbox"/>
Hydric Soil Present? Yes _____ No <input checked="" type="checkbox"/>	
Wetland Hydrology Present? Yes <input checked="" type="checkbox"/> No _____	
Remarks: Conditions were wetter than normal according to the antecedent precipitation tool, but there had not been rain for several days prior to the site visit. This is a depression that appears to seasonally pool with stormwater but has no hydrophytic vegetation or hydric soils to qualify as a wetland.

Depth (inches)	Matrix		Redox Features				Texture	Remarks
	Color (moist)	%	Color (moist)	%	Type <sup>1</sup>	Loc <sup>2</sup>		
0 - 12	10YR 3/2	100					Silt Loam	
12 - 24	10YR 4/2	100					Silt Loam	
-								
-								
-								
-								
-								
-

Soil dry at the time of the delineation, water stained leaves is likely caused by seasonal flooding of stormwater due to the topography of the area creating a slight depression.

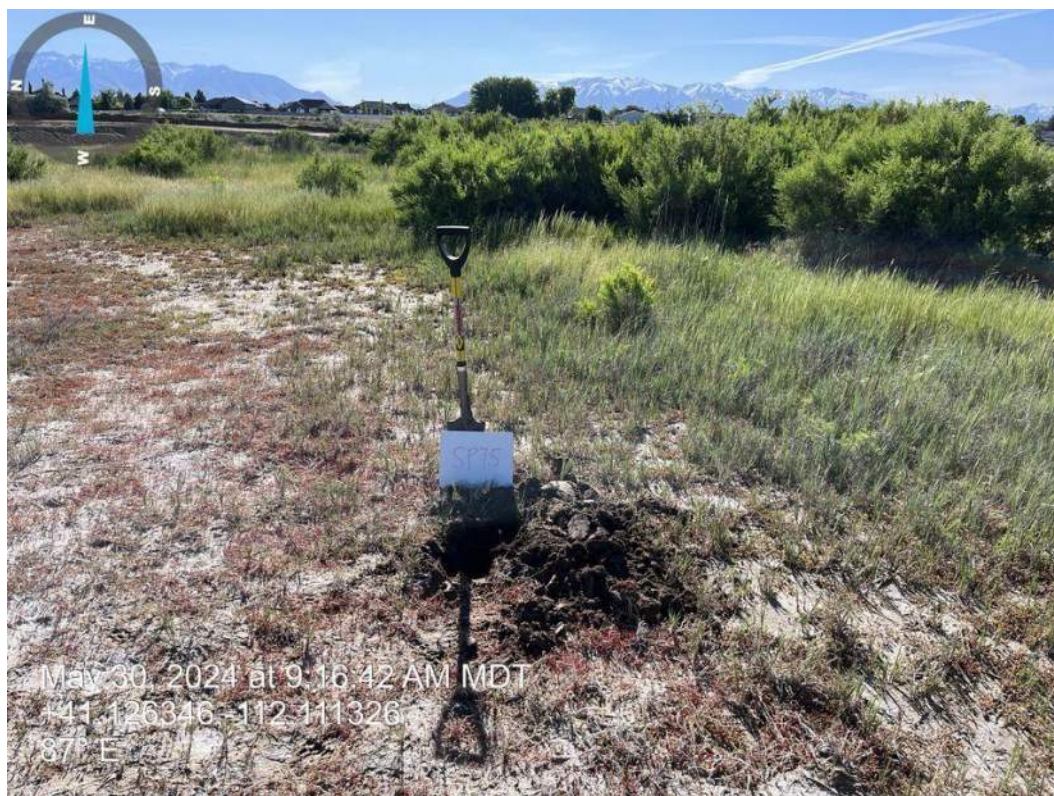
**Sample Point 75**

Depth (inches)	Matrix		Redox Features				Texture	Remarks
	Color (moist)	%	Color (moist)	%	Type <sup>1</sup>	Loc <sup>2</sup>		
0 - 1	10YR 2/2	100					Loam	
5 - 10	10YR 2/3	100					Clay	
10 - 16	10YR 3/4	100	10YR 5/4	1			Silty Clay Loam	
-								
-								
-								
-								
-

dry, moist but not saturated

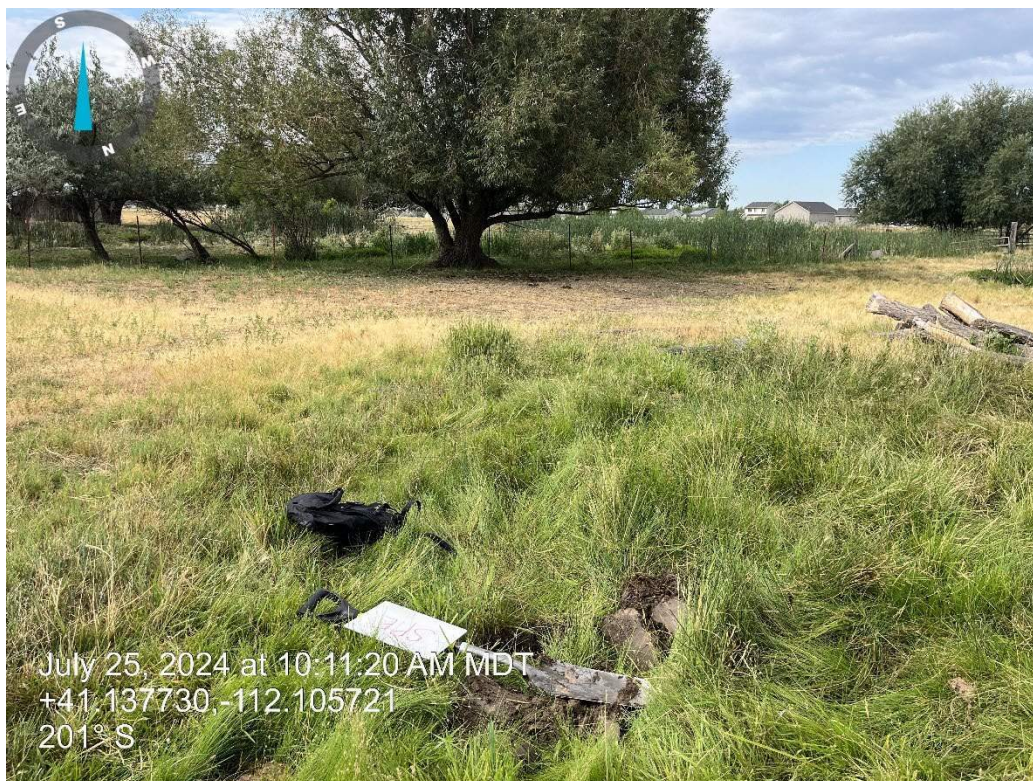
**Sample Point 81**

This area is likely wetter or occasionally flooded earlier in the season.

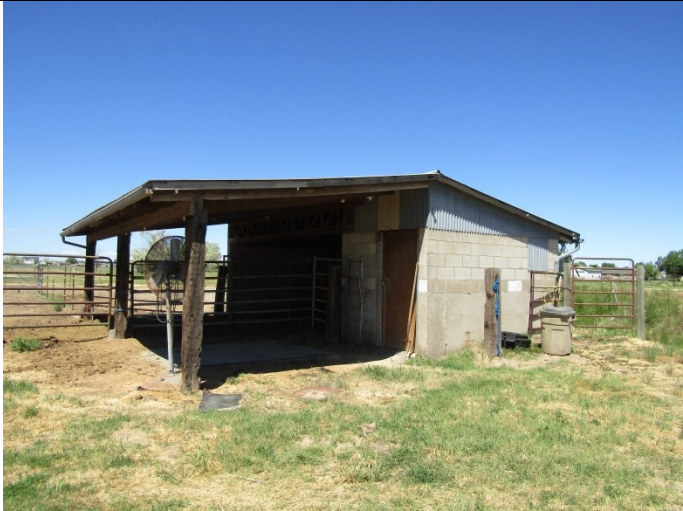
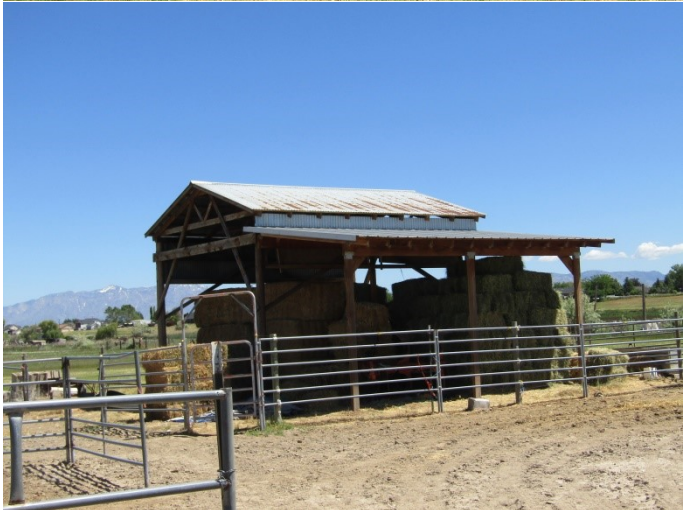
Address	Year Built	Description	Eligibility Evaluation	Photo
~4300 W 300 N	c. 1968	Two agricultural outbuildings, including a small barn/animal shelter and a hay hold. The barn/shelter is constructed of concrete block, wood framing, and corrugated metal. The hay hold is constructed of timber framing and corrugated metal cladding and roofing. Alterations appear limited to patching and repairs of construction materials in the modern era. No obvious historical dwellings are located near these buildings.	Not eligible

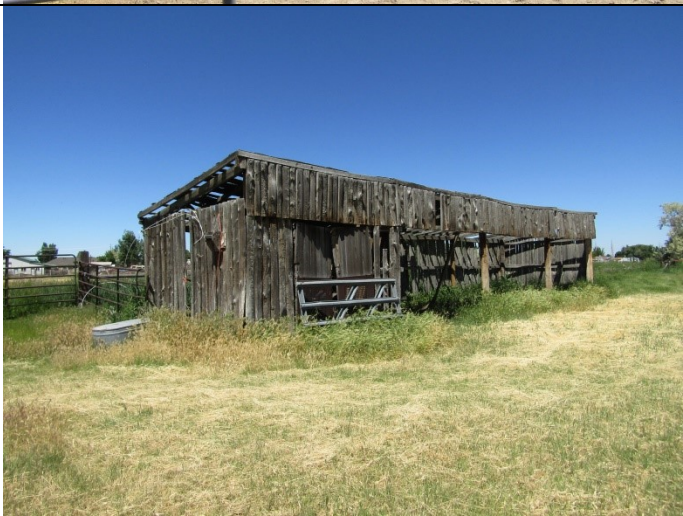
~4320 W 300 N	c. 1960	One agricultural outbuilding—a loafing shed/animal shelter. The building is constructed of wood framing and raw lumber vertical planks. Alterations appear limited to structural deterioration, especially loss of roofing materials. No obvious historical dwellings are located near this outbuilding.	Not eligible

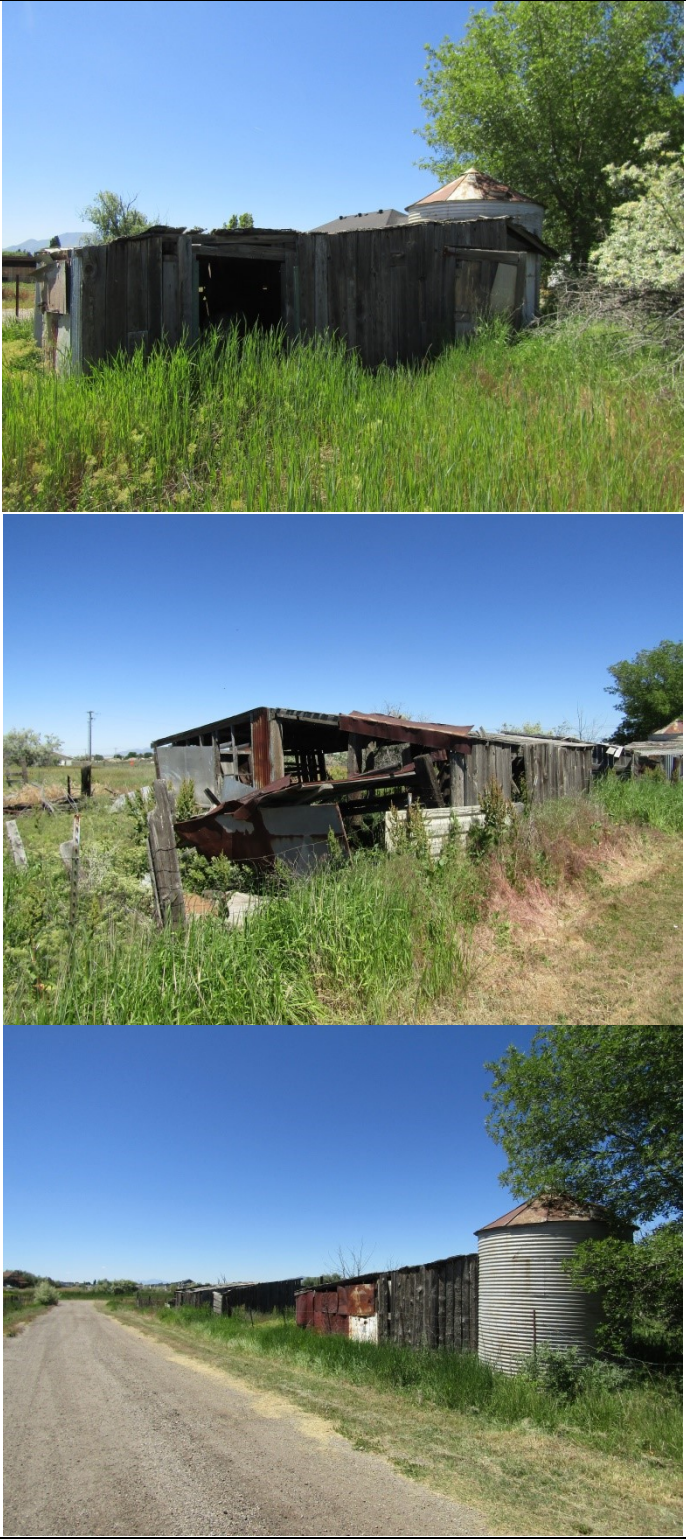
Address	Year Built	Description	Eligibility Evaluation	Photo
4133 W 1800 N	c. 1971	Agricultural outbuilding complex including a short, corrugated metal silo, a small barn, a small shed, and ruins of another unidentifiable structure. The buildings are constructed of wood framing with raw lumber vertical plank and corrugated metal siding and roofing. All of the structures except for the silo exhibit extensive deterioration, loss of cladding and roofing, and partial collapse. No historical dwellings are located near these buildings. The only dwellings in the area date well into the modern era.	Not eligible

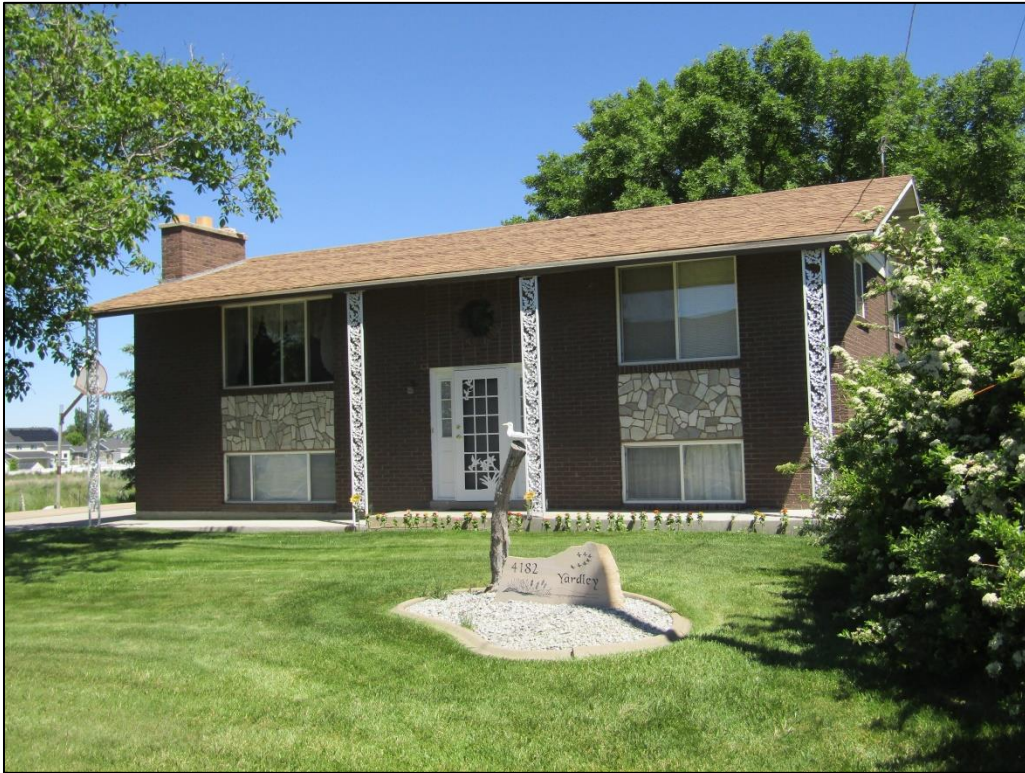
The visible alterations to the exterior of the dwelling include modern windows in unaltered original openings throughout the building. Replacement of original windows and siding are, perhaps, the most common alterations made to Split-level/Split-entry dwellings built during the 1960s and 1970s. The landscape of the property appears consistent with the time of construction for the dwelling.

The subject property is in its original location and continues to present its original design as a Split-level single-family residence of the 1970s. Nonetheless, the property's replaced windows reduce the property's level of integrity to "good".

**Overview of dwelling; looking northwest**

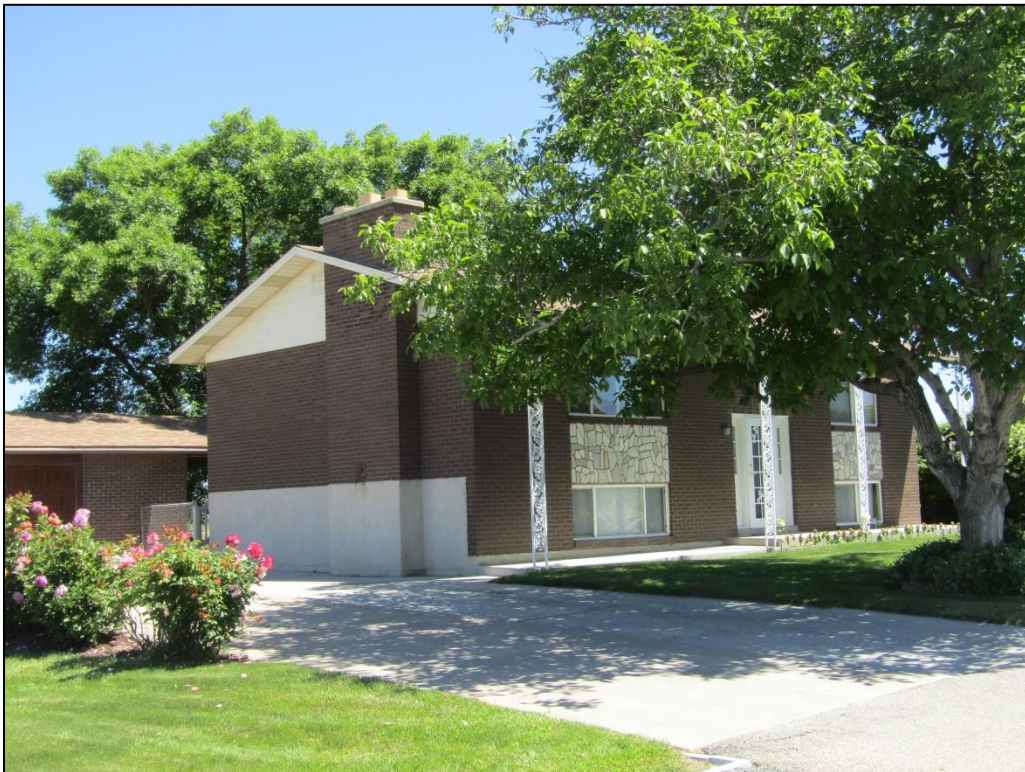
**Overview of dwelling; looking northeast**

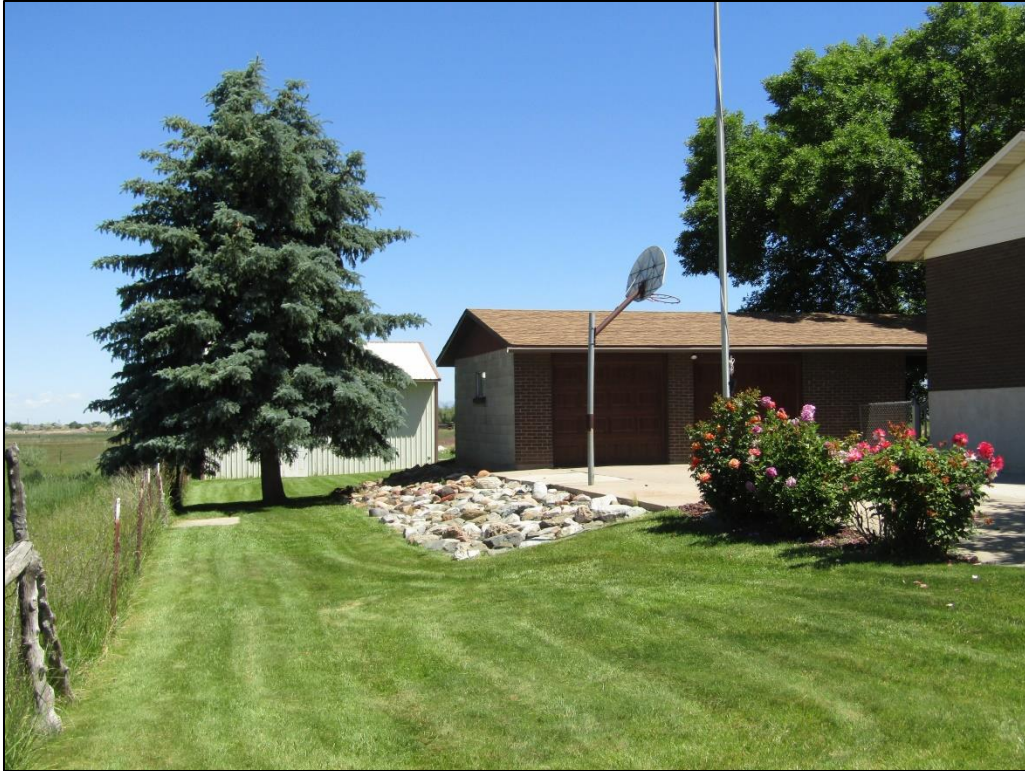
**Visible outbuildings; looking north**

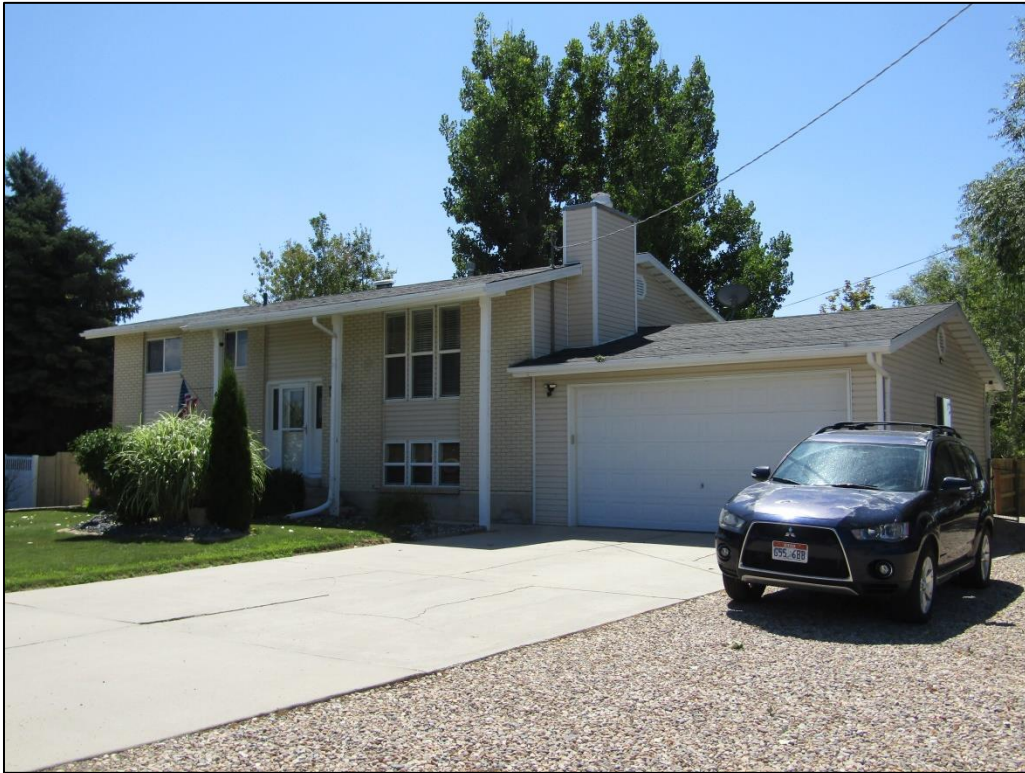
The visible alterations to the exterior of the dwelling include modern windows in unaltered original openings throughout the building and extensive use of modern vinyl siding along with the original brick cladding. Replacement of original windows and siding are, perhaps, the most common alterations made to Split-level dwellings built during the 1960s and 1970s. The landscape of the property appears consistent with the time of construction for the dwelling.

The subject property is in its original location and continues to present its original design as a Split-level single-family residence of the 1970s. Nonetheless, the property's replaced windows and vinyl siding reduce the property's level of integrity to "fair". Unaltered Split-level properties are present elsewhere in West Point, including on adjacent properties, and are better examples of vernacular Split-level forms.

**Overview of dwelling; looking southeast**

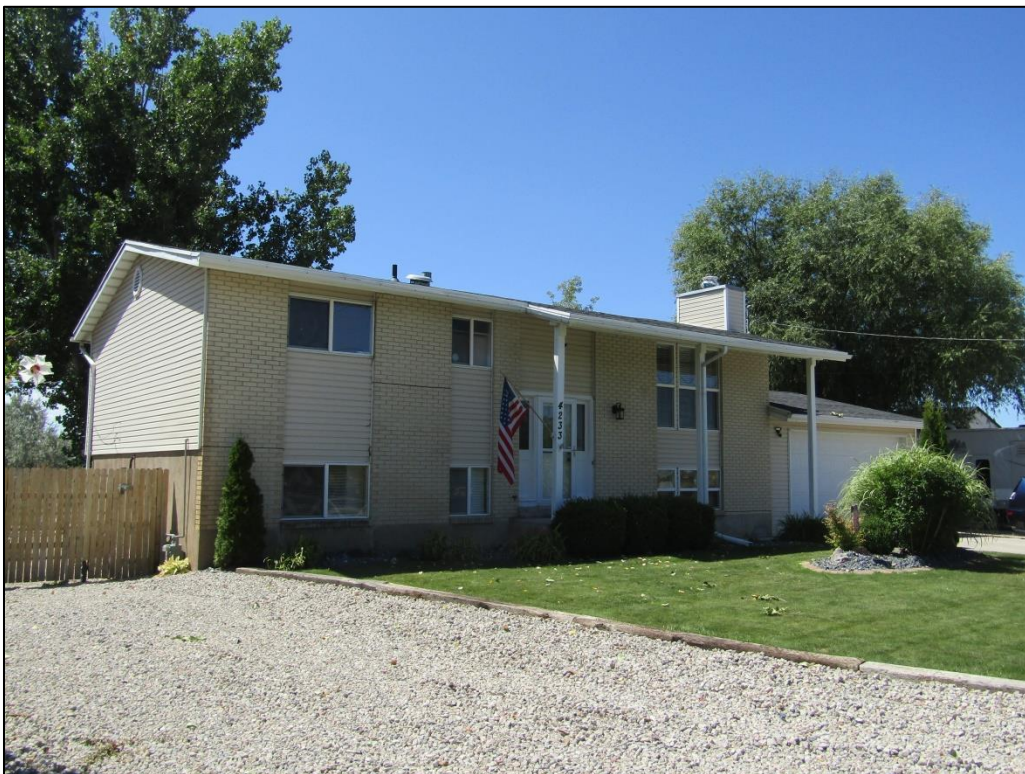
**Overview of dwelling; looking southwest**

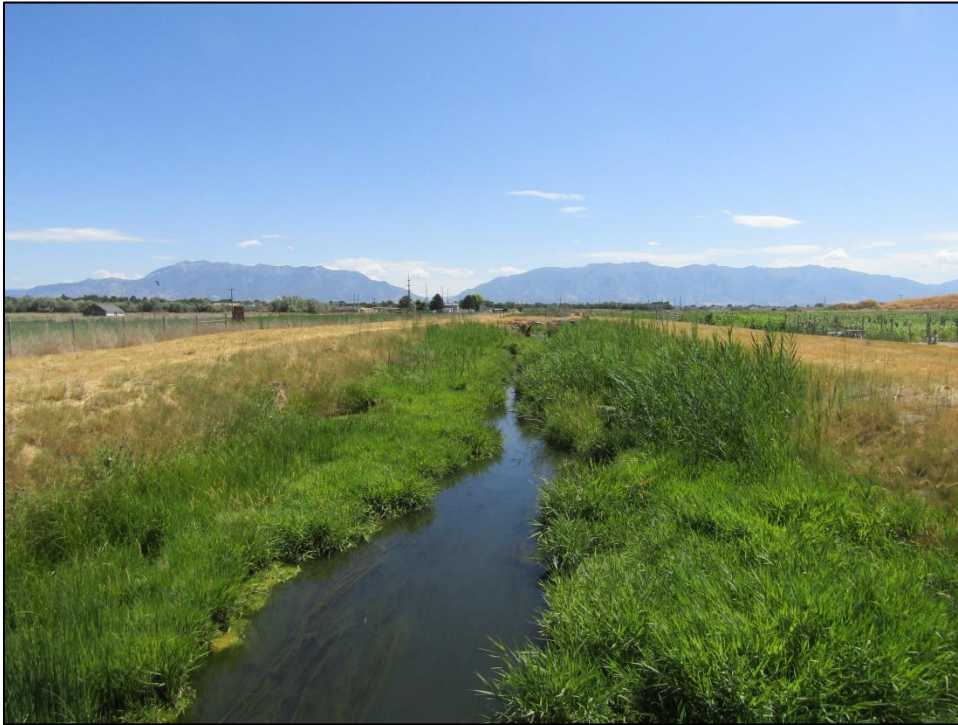
This site is an unnamed land drain (ditch) located near 200 South in West Point. The segment of the site documented here begins on the east at the edge of the Schneider's Bluff Golf Course where the ditch channel daylights and extends to the west for 717 meters. Along this segment, the ditch is unlined and measures approximately 20 feet wide across the top by 14-15 feet wide at the bottom. It has a shallow U-shaped cross-section and is roughly 4 feet deep. No water control features were observed along the documented segment, but several modern concrete slab crossings and corrugated metal pipe culverts were noted.

**42DV138; Overview of open ditch segment; looking east**

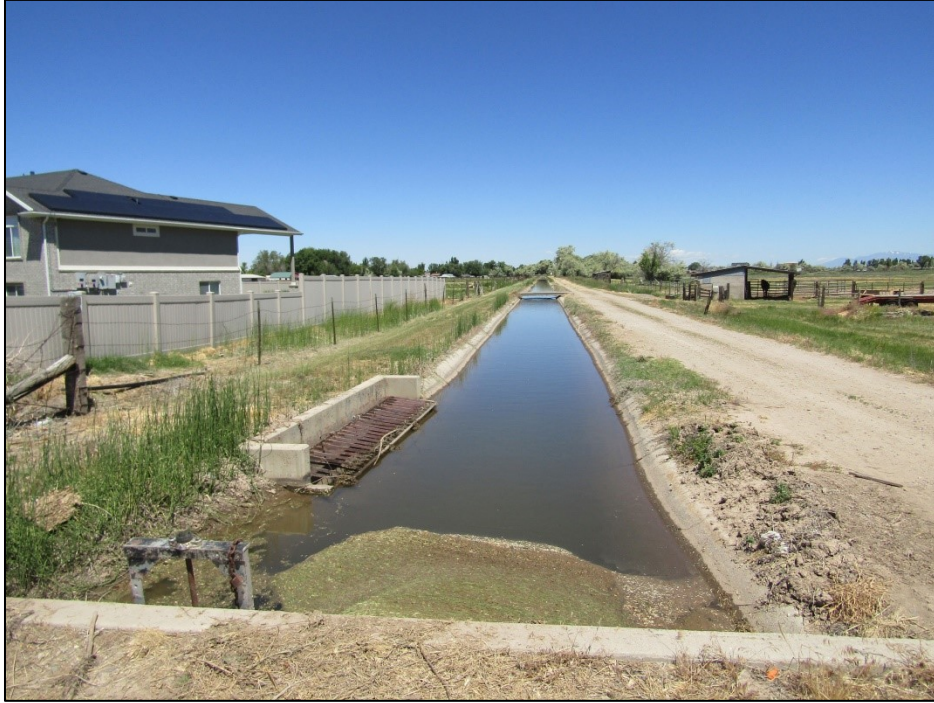
**42DV158; Main canal at 300 North (southern section); looking north-northwest**

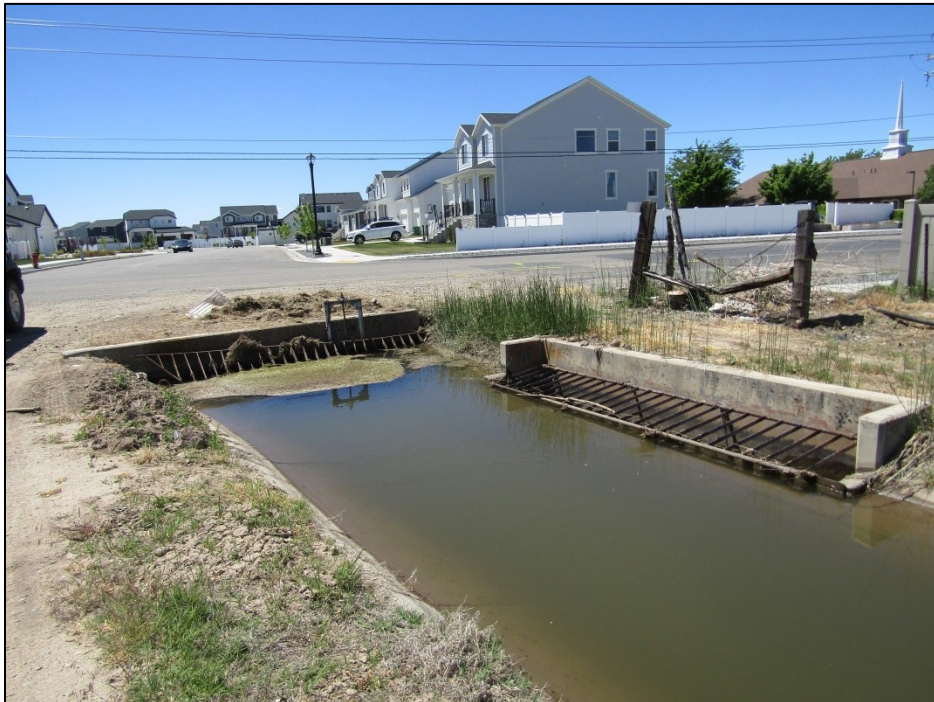
**42DV158; Main canal at 300 North showing trash racks, diversions, and culvert; looking south**

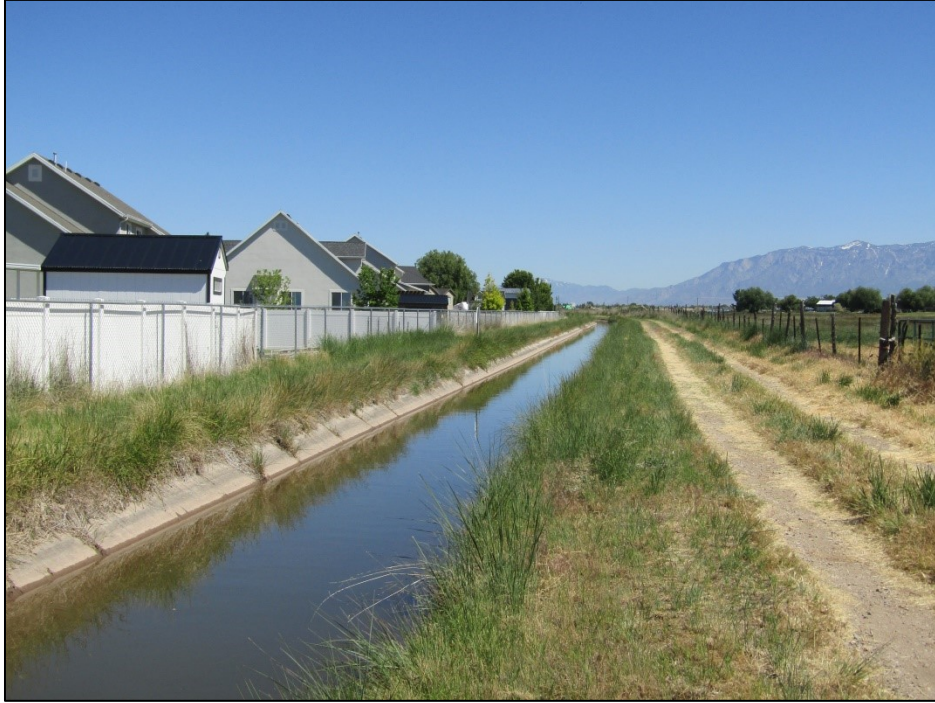
**42DV158; Central section; looking north**

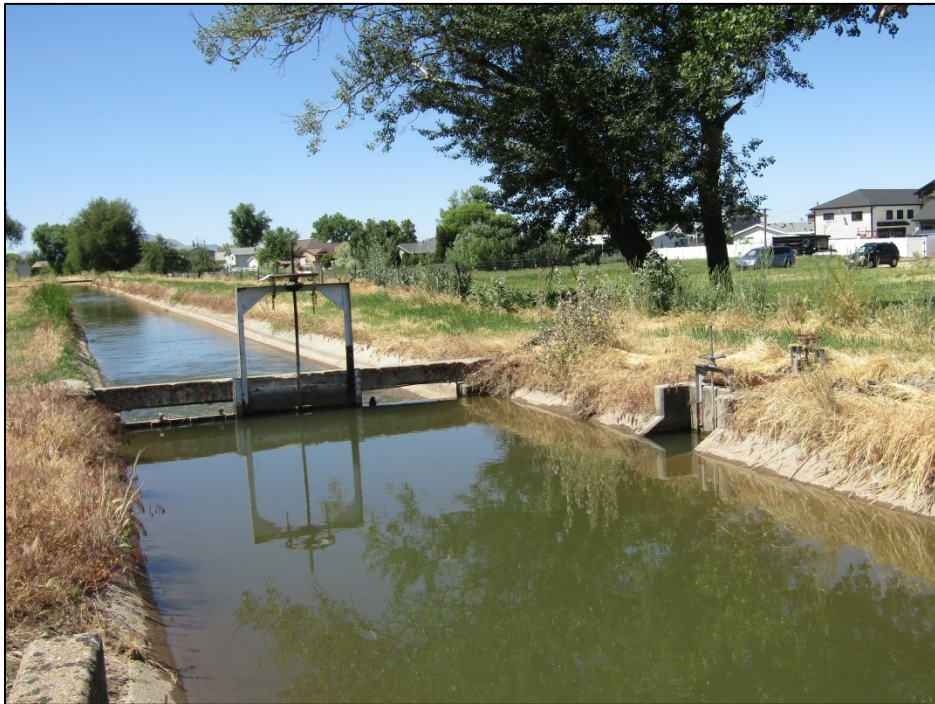
**42DV158; Hooper Canal central section – water control features near 800 North; looking south**

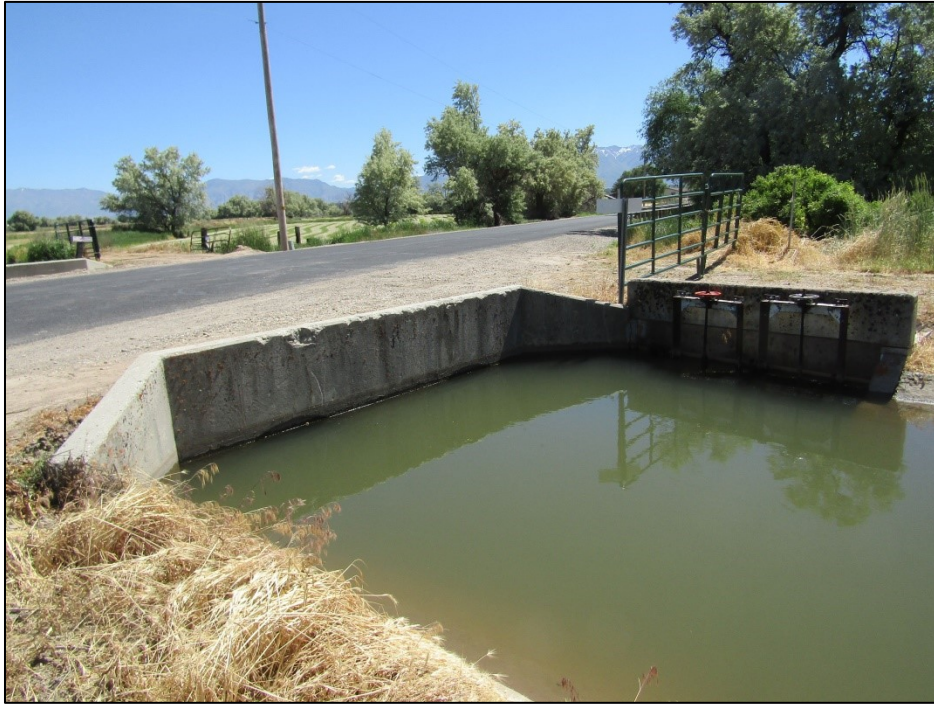
**42DV158; Hooper Canal central section – water control features at 800 North; looking northeast**

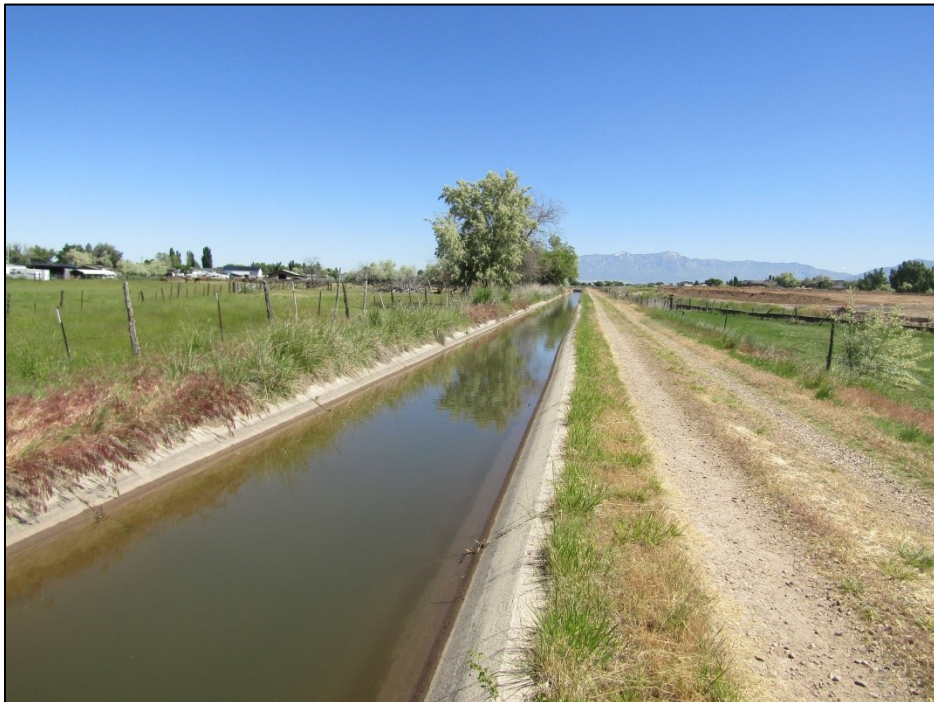
**42DV158; Hooper Canal northern section; looking north**

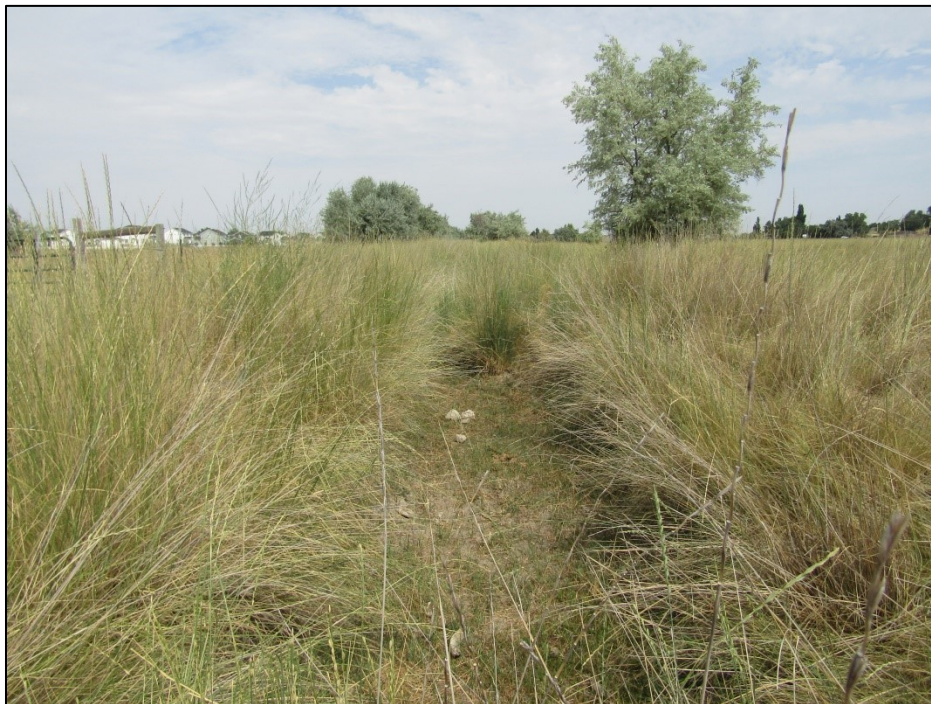
**42DV158; Distribution ditch on southern section of main canal; looking west**
