## DEPARTMENT OF TRANSPORTATION

SUBJECT: UDOT Project Number S-R199 (381)  
SR-177; SR-193 to 1800 N. (PIN 20927)  
*Environmental Impact Statement Re-evaluation 15*

Traffic Noise Study

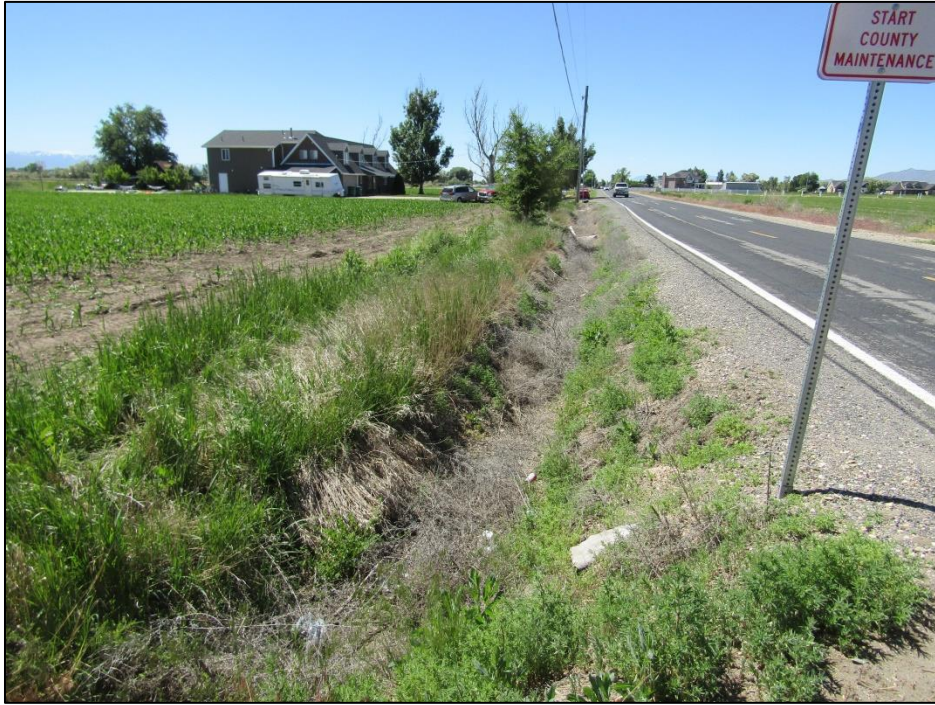
**42DV182; Main lateral along 1800 North; looking east**

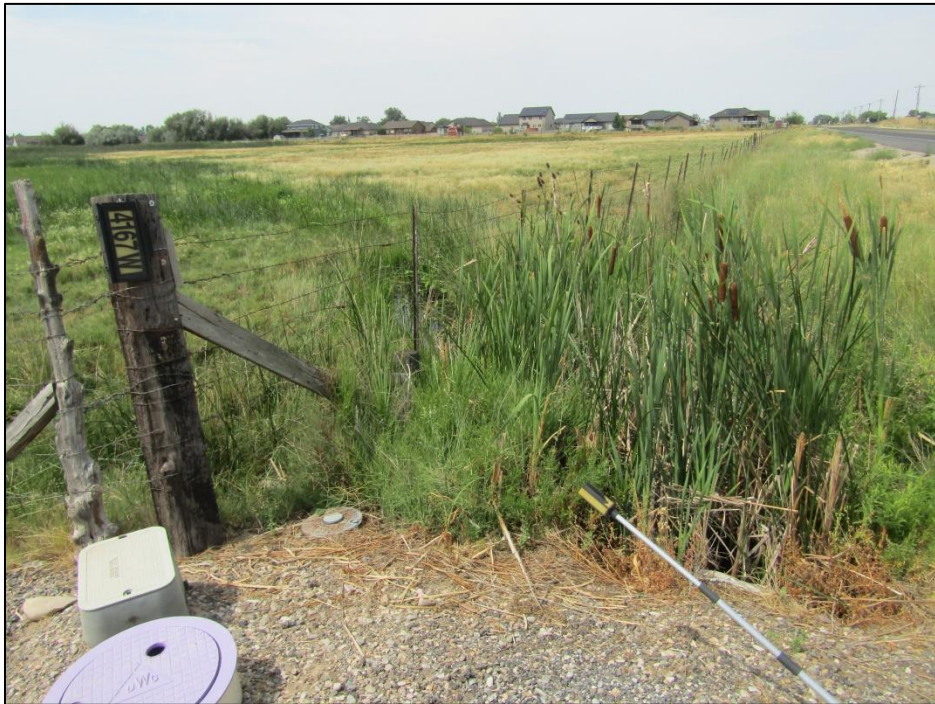
**42DV182; Field ditches (reeds and darker grass); looking west-southwest**

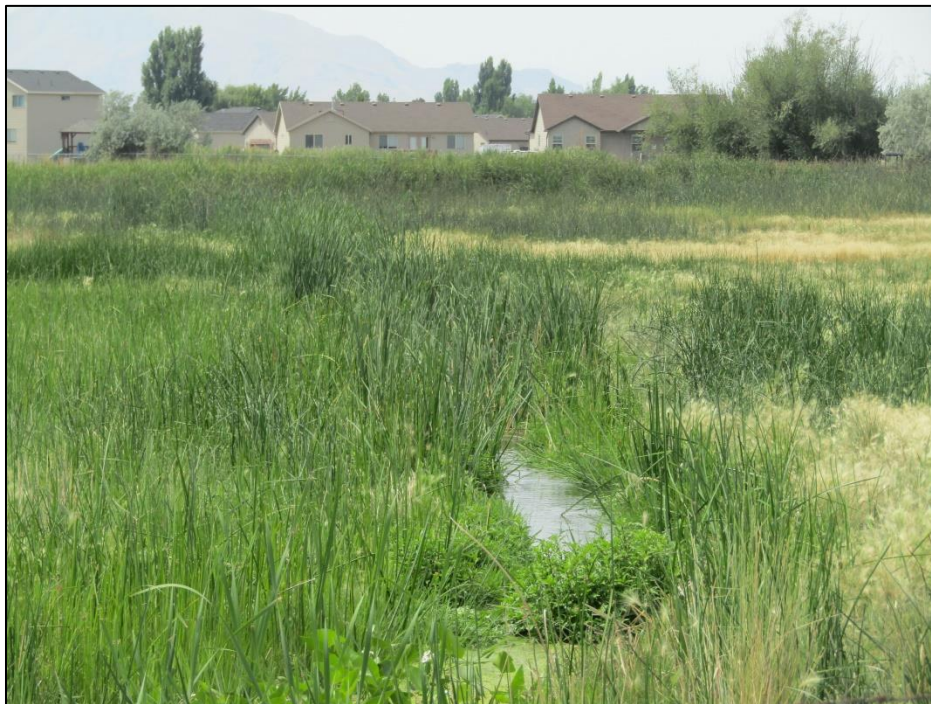
**42DV182; Field ditches (reeds and darker grass); looking southwest**
